Sewer **i**nspection **a**utonomous **r**obot

D28.10 - Serviceability Inspection

SIAR Consortium

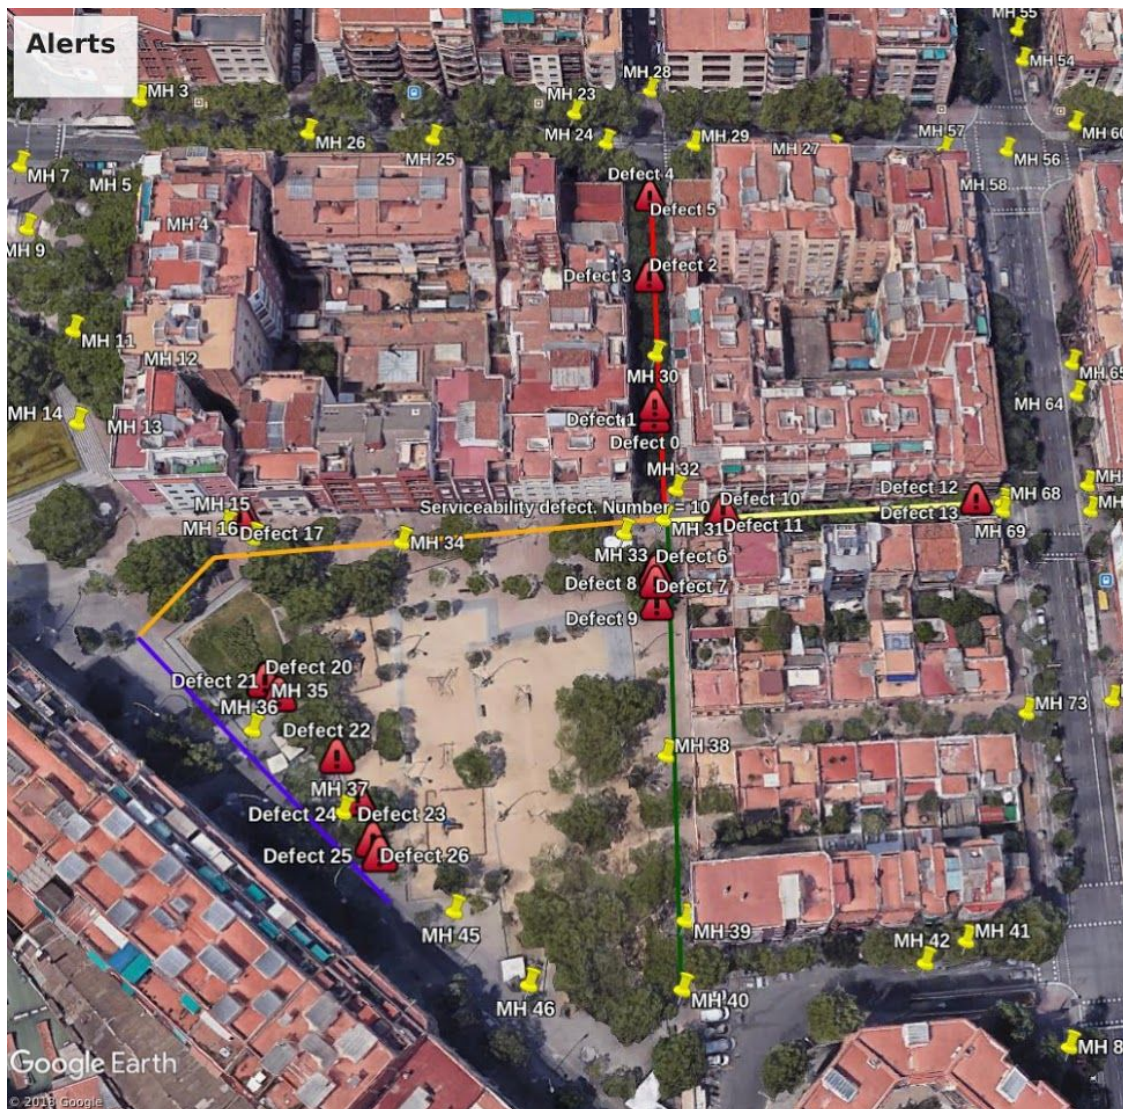
Figure 4.1 represents the raw report as generated by our detection algorithm. Note that the number of defects is 26 instead of 13. The explanation is simple: our detection algorithm currently raises one alarm whenever a serviceability loss is detected and another when the serviceability goes back to normality.

As a summary, our algorithm detected two main zones where there are very noticeable defects where human intervention would be needed for cleaning purposes. The first zone corresponds to Serviceability defects from 6 to 9 (see Figure 4.1) that were found in the second inspected section (see Figure 3.1). Then, other defects were found at the end of section 4. In these cases the serviceability was reduced in a great extent or even there were accumulated dirt that prevented the water to flow in these areas. The other defects were punctual or were due to false alerts. As a last remark, please note that all the alarms generated by our module are listed here with no exception. In the process, only four false alarms were generated in a track of more than 400m. Therefore, our algorithm can be used

Figure 4.1: Automatically generated serviceability report for Virrei Amat area. The yellow spots show the location of the manholes. The red spots indicate the generated alerts.

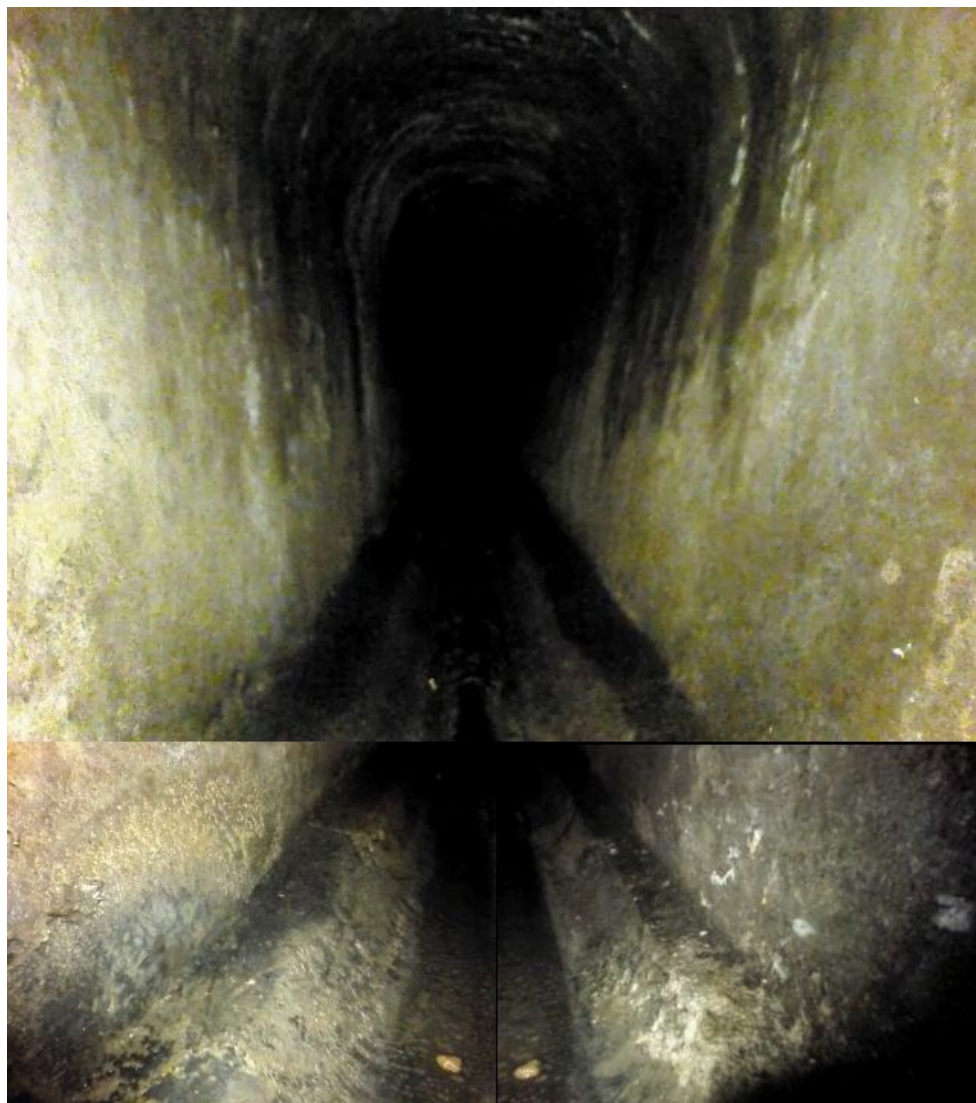
Figure 4.2 represents a snapshot of the defects related to Alert 1. In this case, minor defects can be found: two little stones in the gutter and some defects in the rightmost curb. This is most probably a false alarm.

Figure 4.2: Composed snapshot of three frontal cameras in Alert 1. Two small stones on the gutter and defects in the rightmost curb can be found.

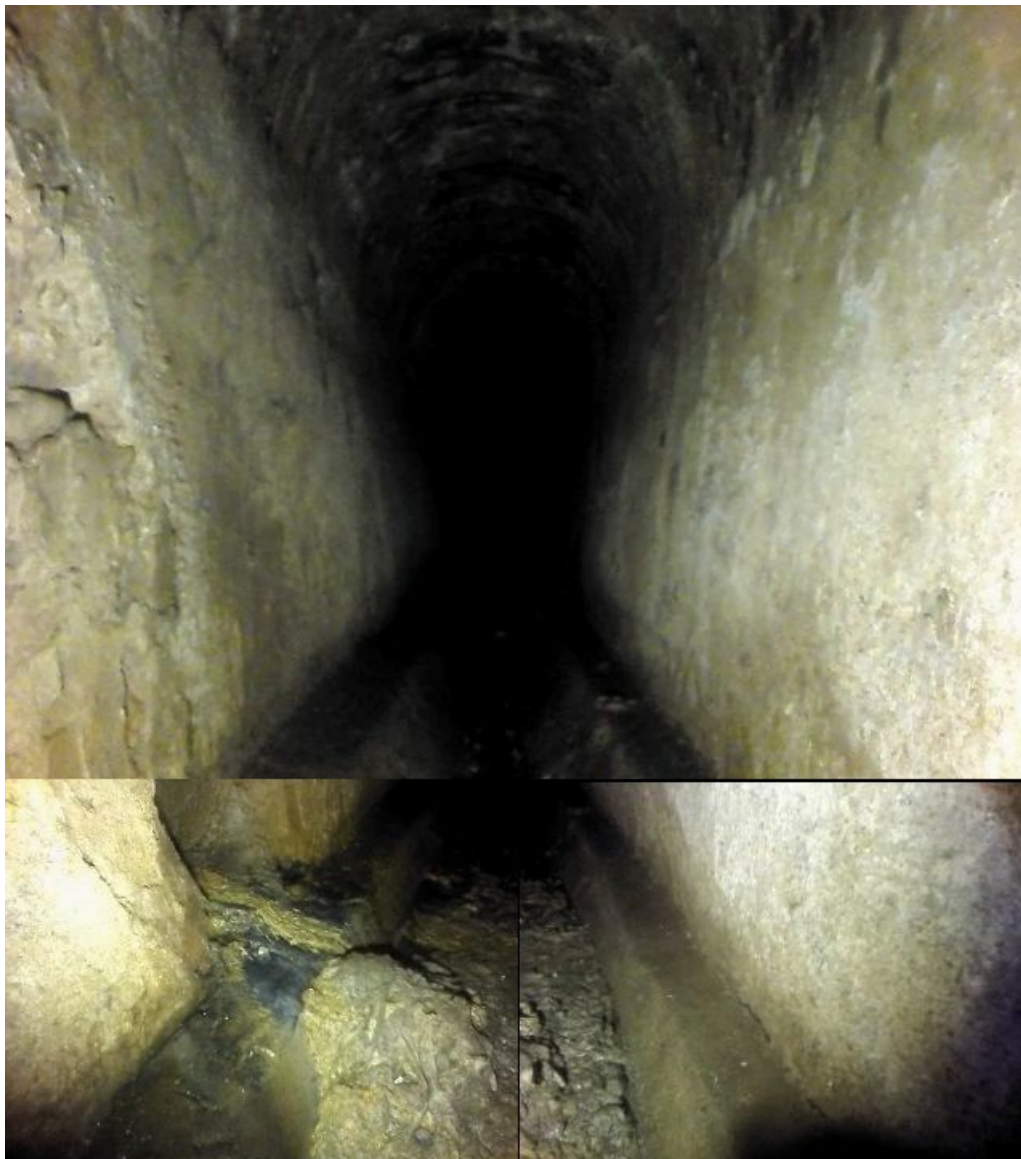
Figure 4.3: Composed snapshot of three frontal cameras in Alert 2.

Figure 4.3 represents a snapshot of the defects related to Alert 2. In this case there are noticeable sediments on the gutter and in the leftmost curb.

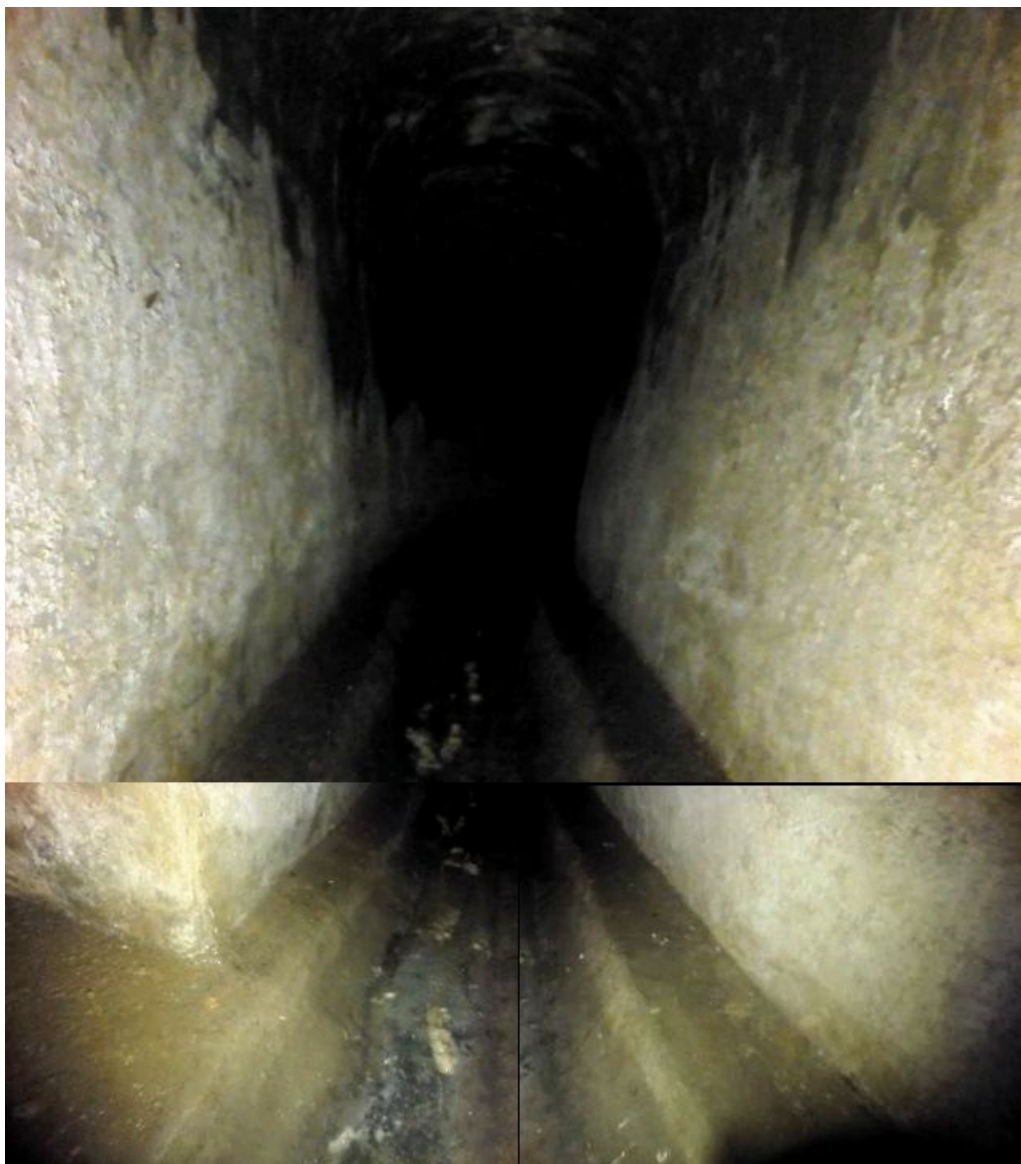
Figure 4.4: Composed snapshot of three frontal cameras in Alert 3.

Figure 4.4 represents a snapshot of the defects related to Alert 3. In this case, minor sediments can be found in the gutter. The defects seem not to be enough to compromise the serviceability of the gutter. This can be considered as a false alarm.

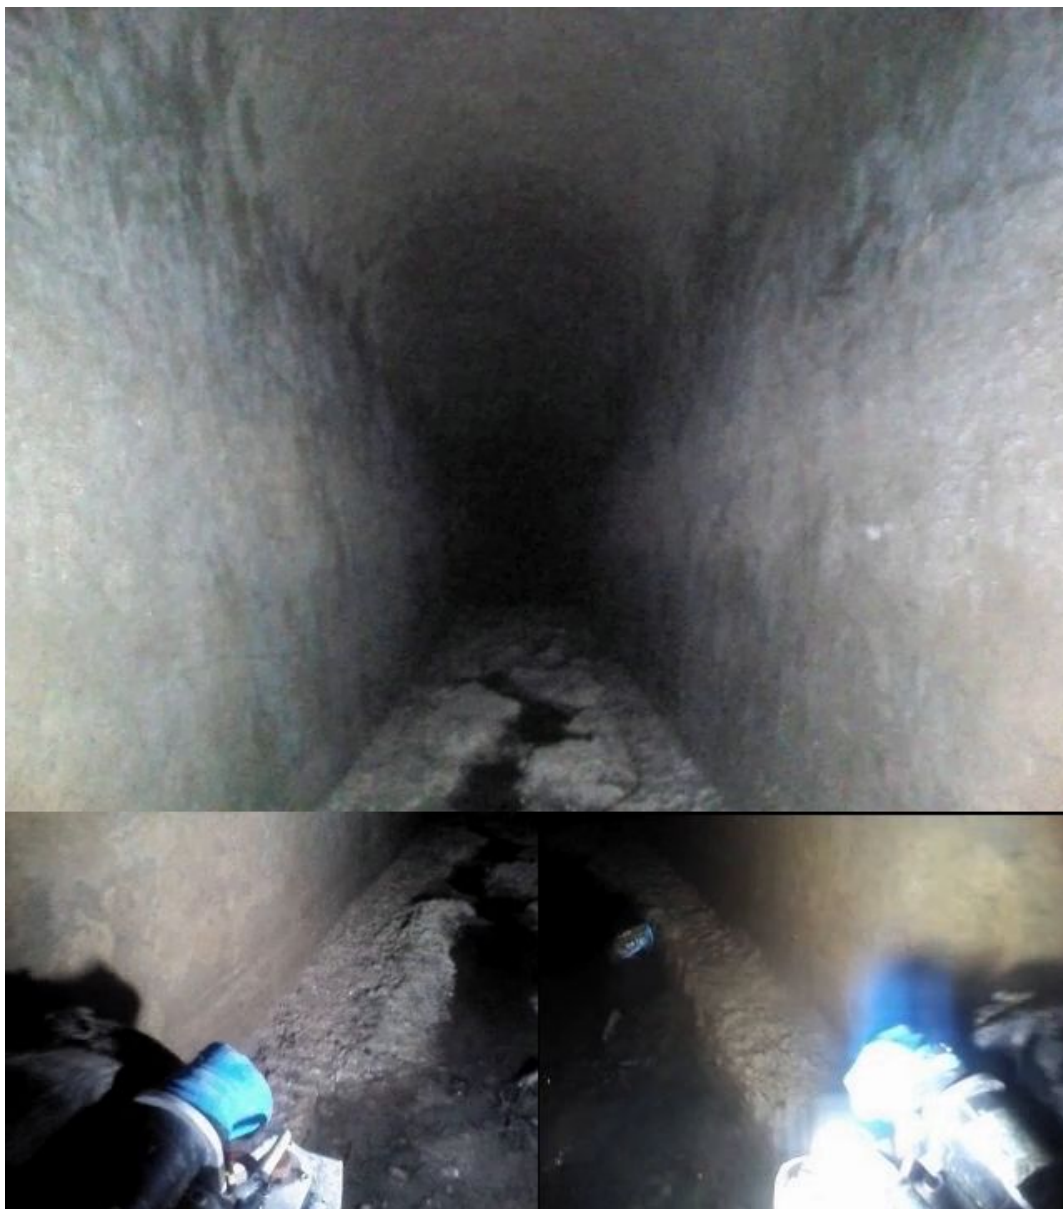
Figure 4.5: Composed snapshot of three rear cameras in Alert 4.

Figure 4.5 represents a snapshot of the defects related to Alert 4. In this case, sediments are accumulated in the gutter and prevent the water from flowing.

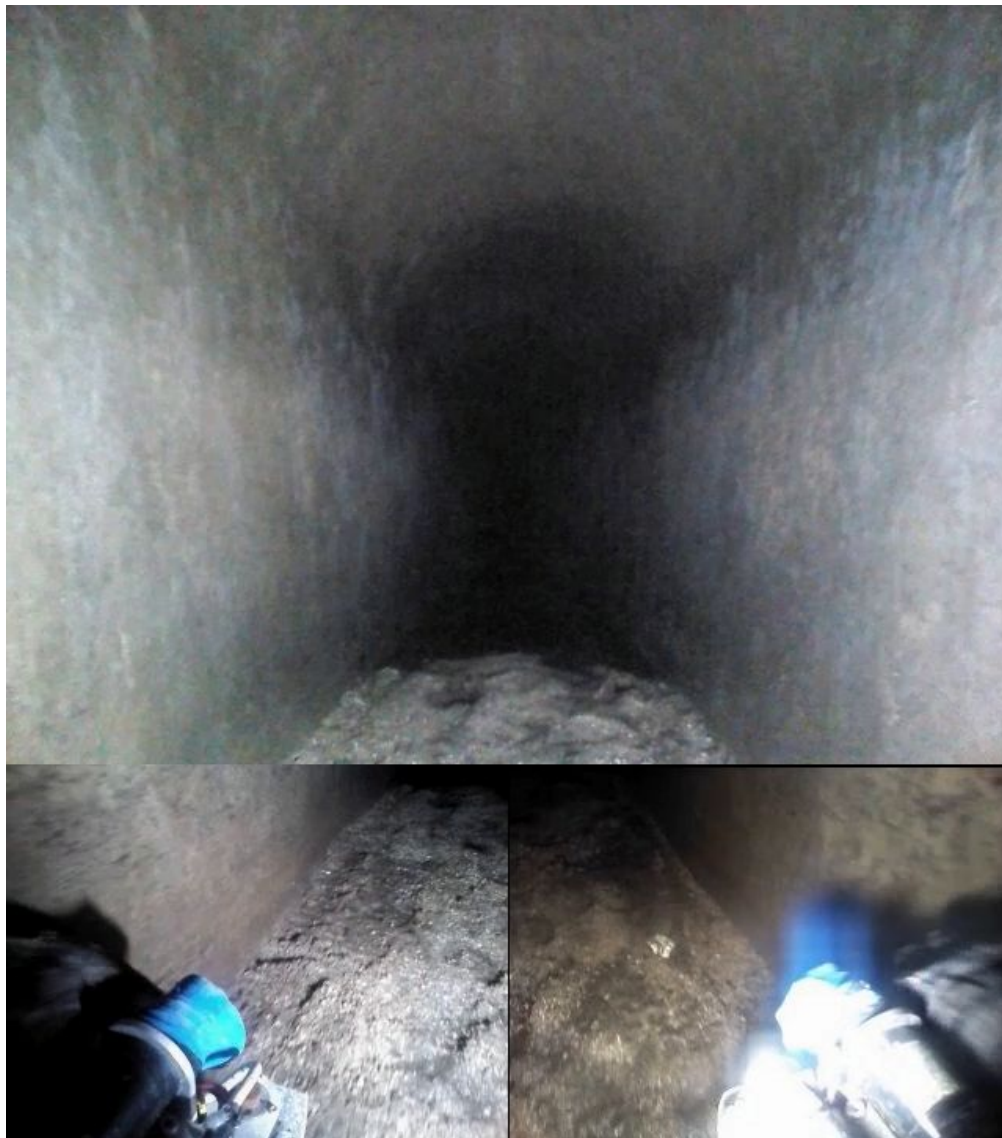
Figure 4.6: Composed snapshot of three rear cameras in Alert 5.

Figure 4.6 represents a snapshot of the defects related to Alert 5. In this case, sediments are accumulated in the gutter and prevent the water from flowing. The accumulated water at the end of the serviceability defect can be found in the video (see Appendix I). This alarm is quite close to Alarm 4 and they can be considered as the same problem.

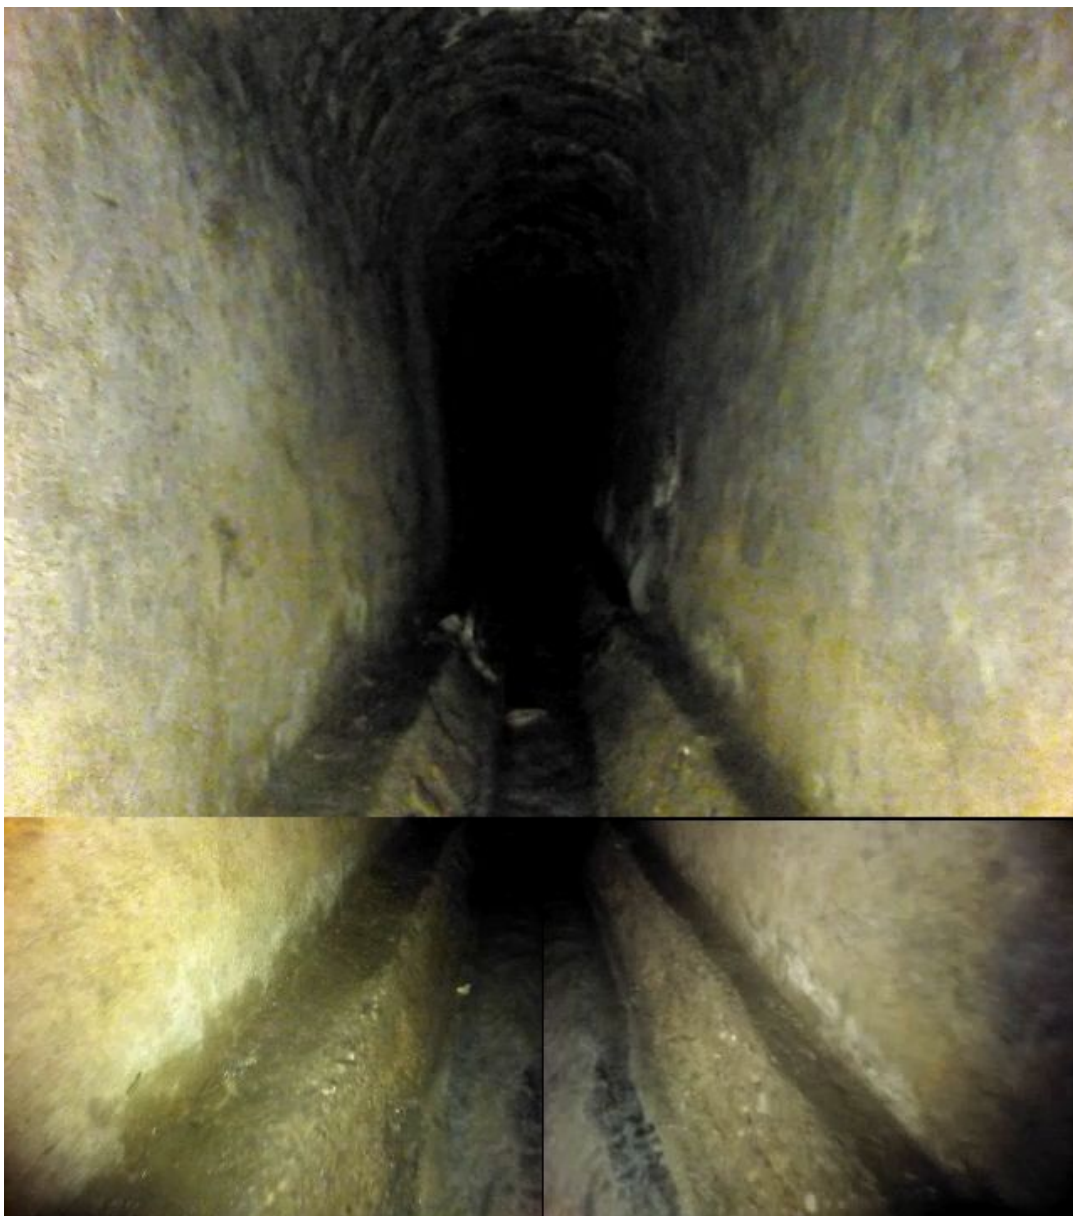
Figure 4.7: Composed snapshot of three rear cameras in Alert 6.

Figure 4.7 represents a snapshot of the defects related to Alert 6. Some minor defects can be found in the gutter and both curbs.

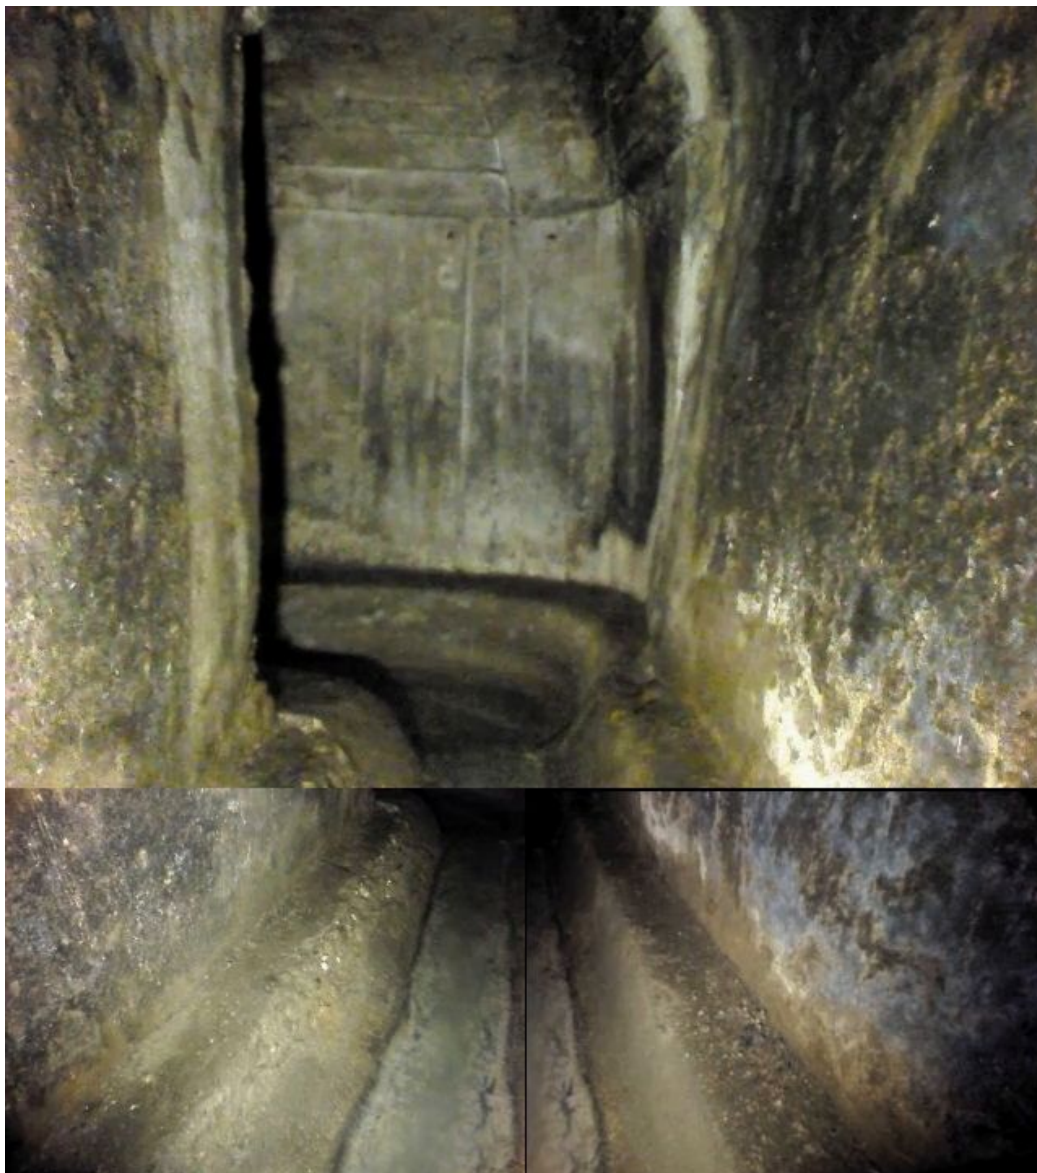
Figure 4.8: Composed snapshot of three frontal cameras in Alert 7.

Figure 4.8 represents a snapshot of the defects related to Alert 7. In this case, it is clearly a false alarm that was raised because of the presence of a curved gallery, as the current detector assumes a straight gallery.

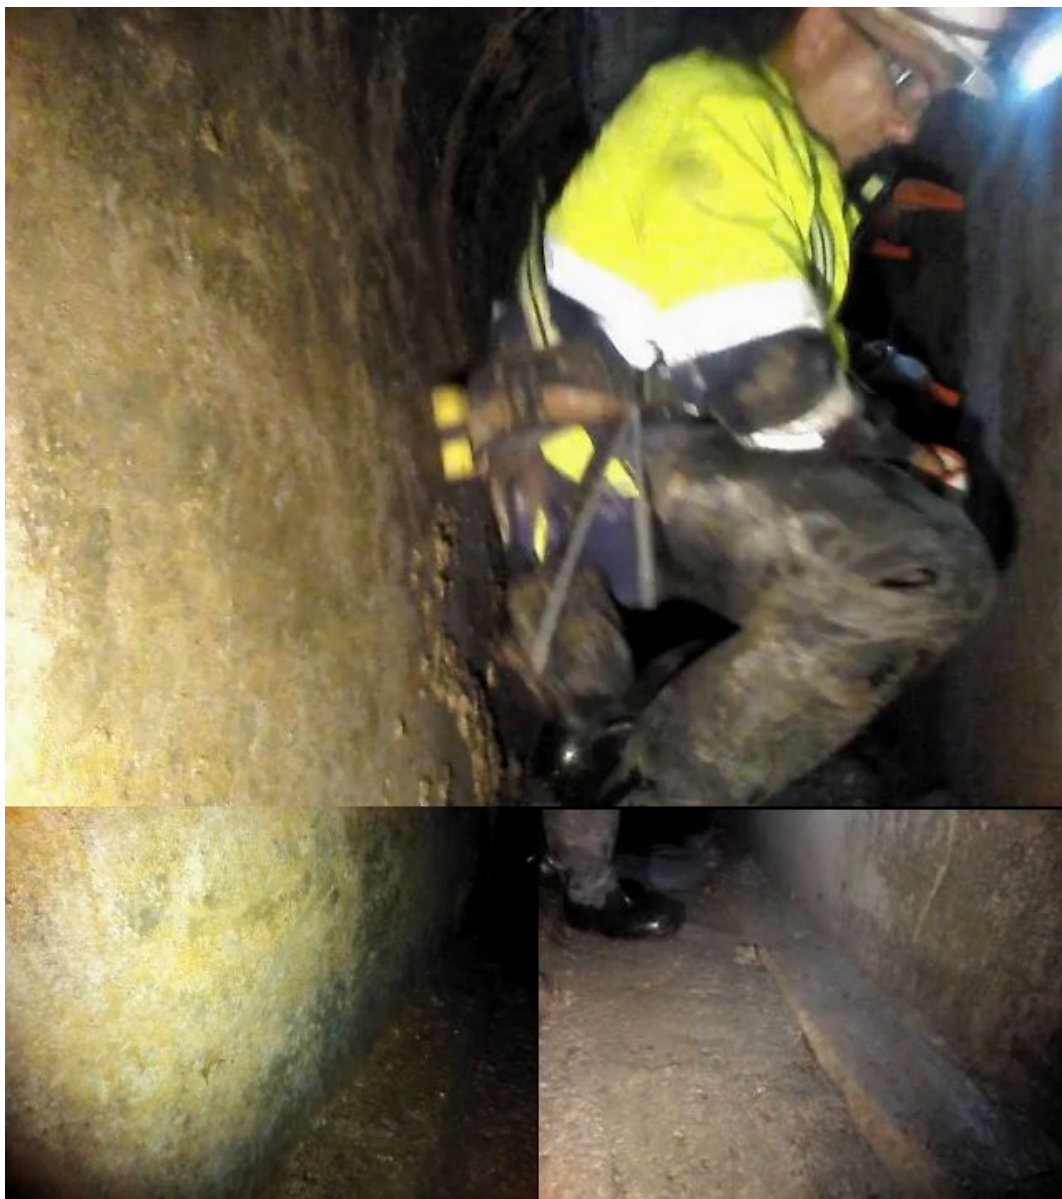
Figure 4.9: Composed snapshot of three frontal cameras in Alert 8.

Figure 4.9 represents a snapshot of the defects related to Alert 8. In this case, a reduction of the serviceability can be found at the gutter.

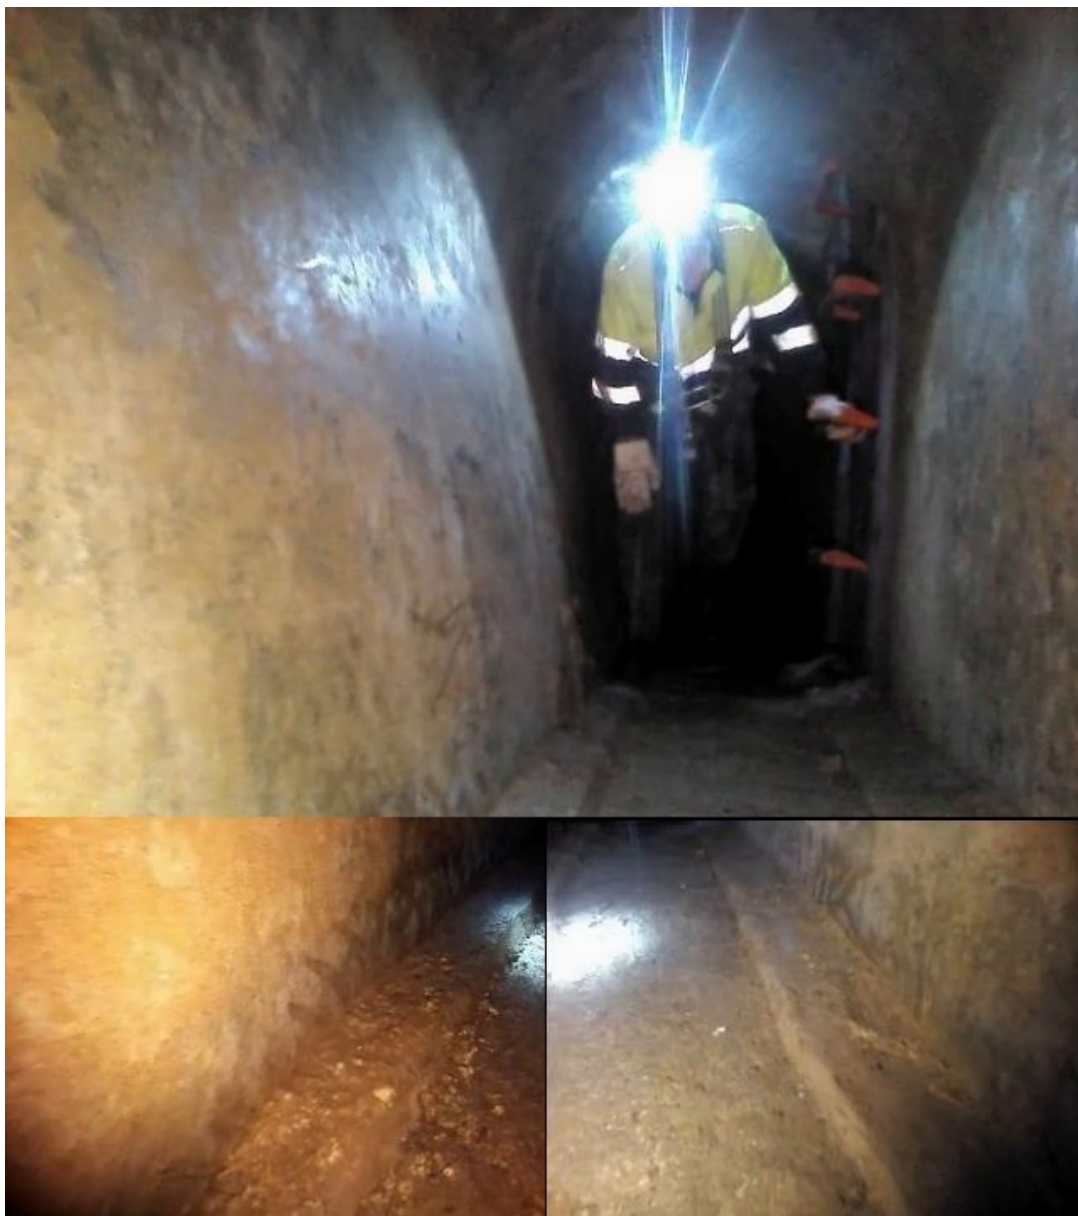
Figure 4.10: Composed snapshot of three frontal cameras in Alert 9.

Figure 4.10 represents a snapshot of the defects related to Alert 9. This alert relates to the same problem as Alert 8.

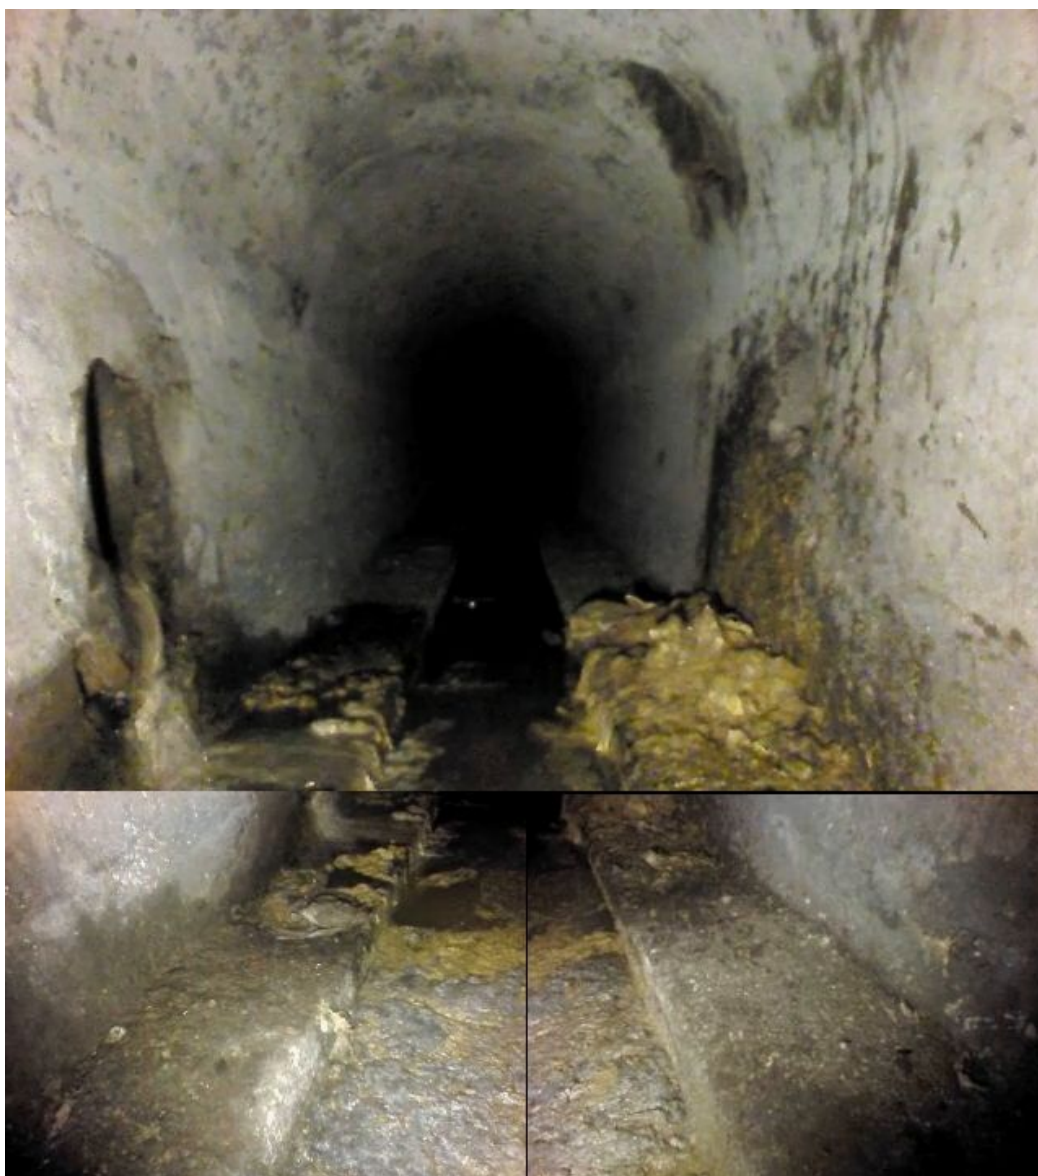
Figure 4.11: Composed snapshot of three frontal cameras in Alert 10.

Figure 4.11 represents a snapshot of the defects related to Alert 10. In this case a noticeable sediment over the rightmost curb can be found. Also, some sediments can be detected at the gutter.

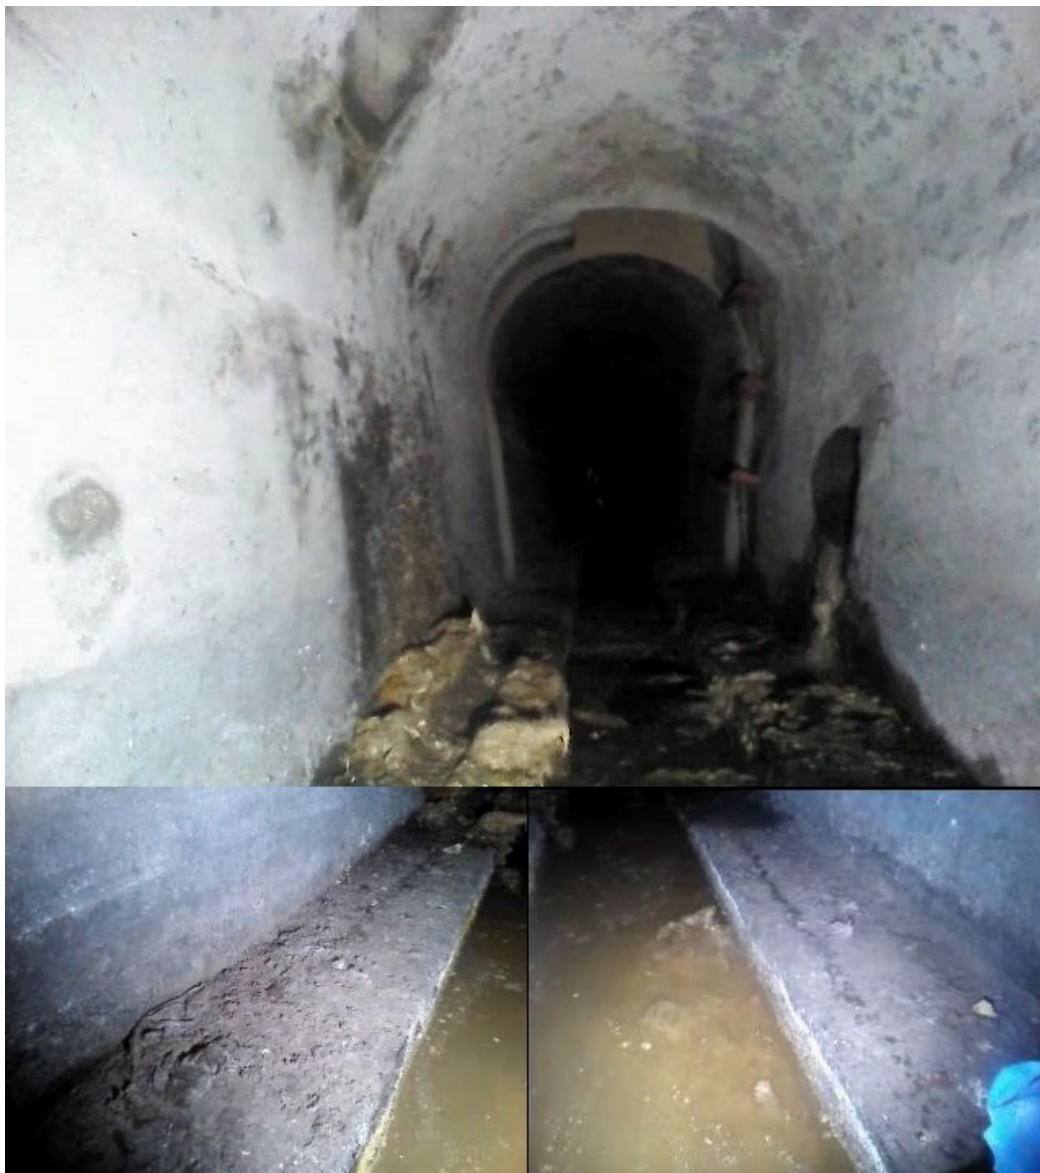
Figure 4.12: Composed snapshot of three rear cameras in Alert 11.

Figure 4.12 represents a snapshot of the defects related to Alert 11. This alert is the same as Alert 10, but seen in another point of view (with the rear cameras). Therefore, they can be merged together.

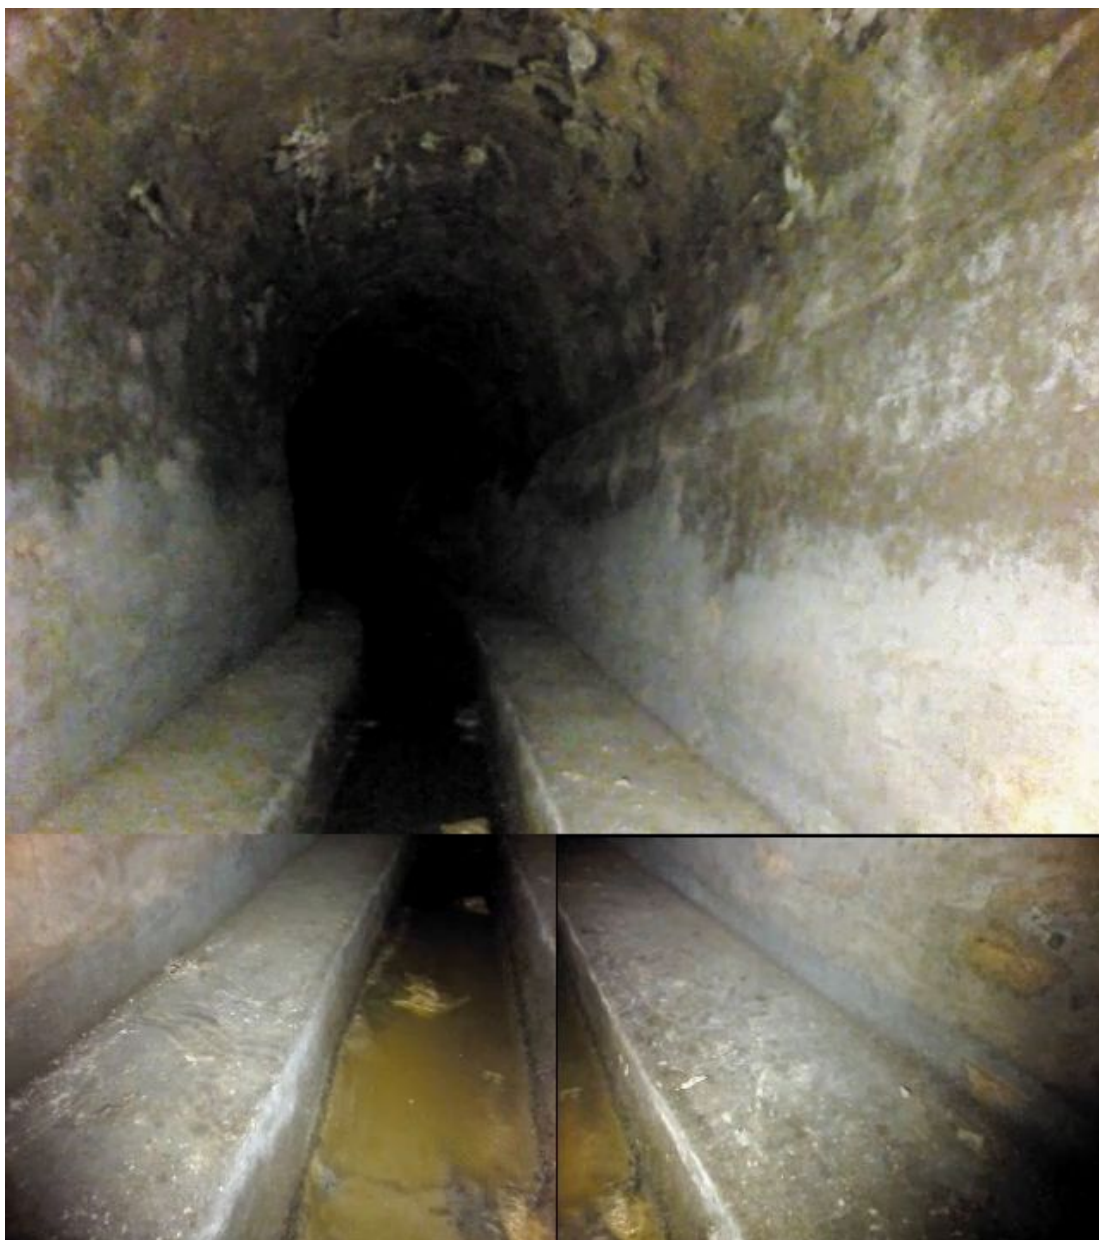
Figure 4.13: Composed snapshot of three frontal cameras in Alert 12.

Figure 4.13 represents a snapshot of the defects related to Alert 12. Some minor sediments can be found in the gutter.

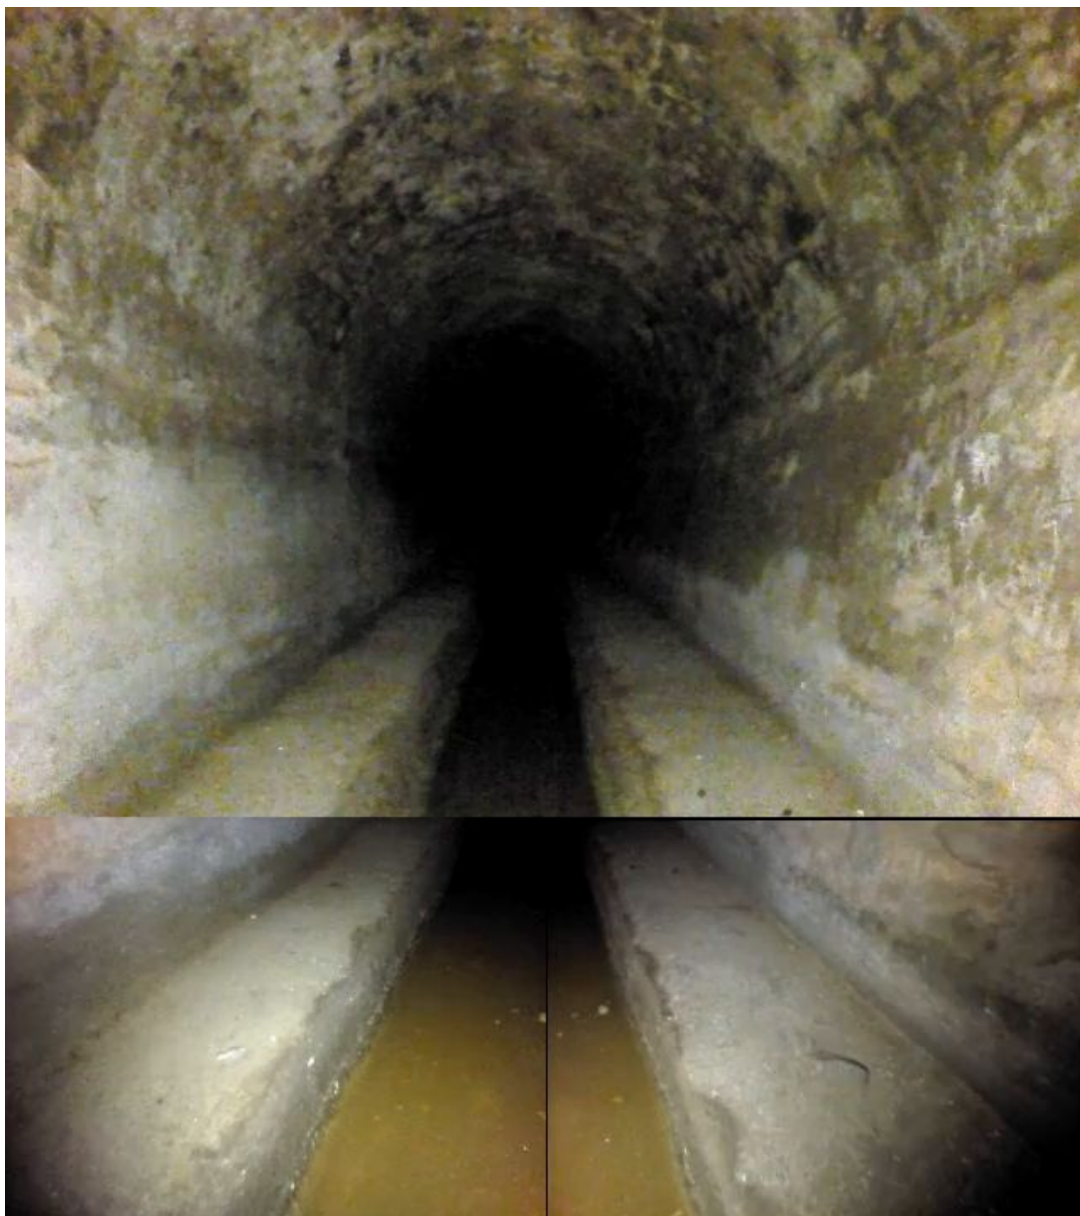
Figure 4.14: Composed snapshot of three frontal cameras in Alert 13.

Figure 4.14 represents a snapshot of the defects related to Alert 13. A medium sized stone can be found in the rightmost curb. However, this is most probably a false alarm.
