Phase III Tests and tests results

ARSI Deliverable D26.10

PDTI Urban Robotics - Sewer Inspection

July 27, 2018

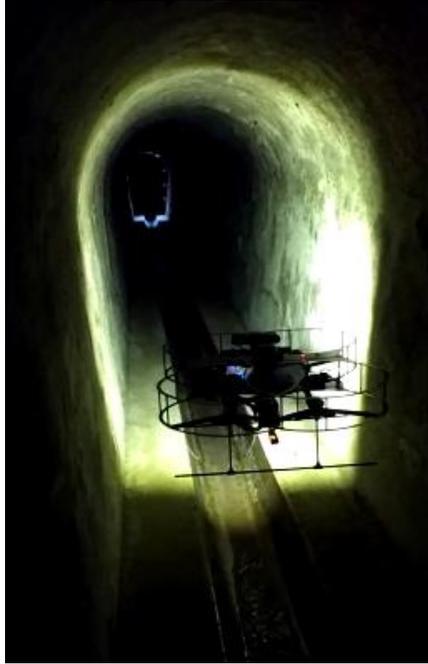
Figure 2: ARSI MAV executing a sewer inspection in Barcelona

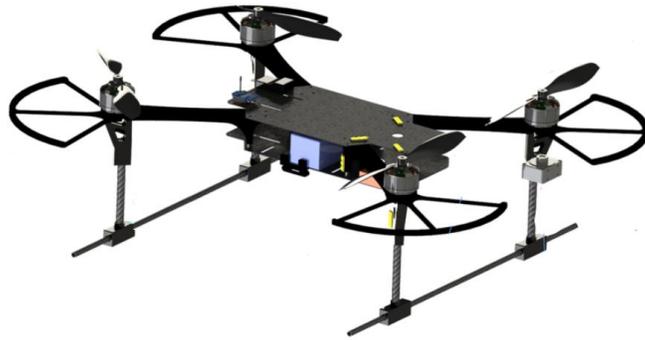
The MAV quadrotor developed in phase II is shown in figure 3. It used 4 motors with 11in (28cm) propellers, powered by a single 6000mAh LiPo battery. It had a nominal flight time of 9 minutes, but field tests showed that the real flight time was closer to 5-6 minutes, after which the low battery power resulted in poor control and unstable flights. The phase II MAV had a payload limit of $\sim 700\text{g}$.

Figure 3: Phase II MAV prototype

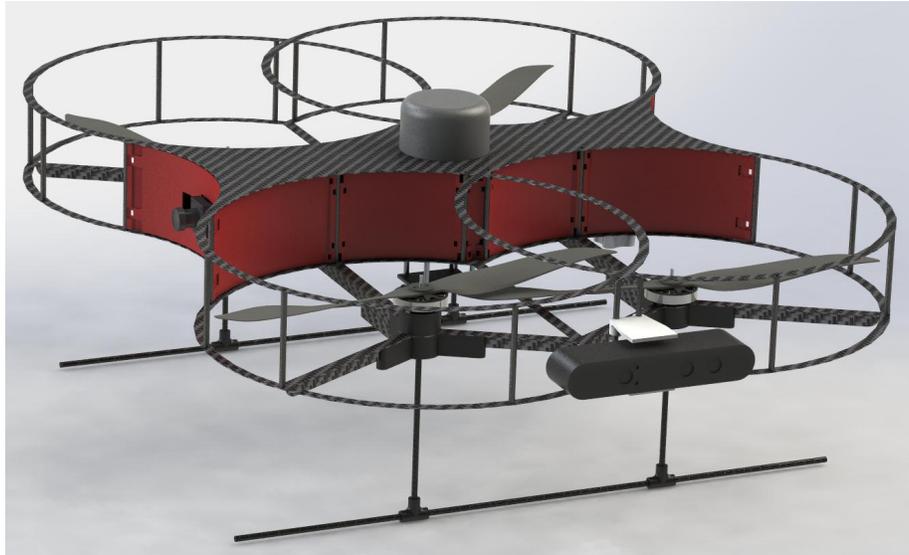
In phase III we partnered with DroneTools, a drone manufacturing company based in Sevilla, Spain. Given our requirements, they proposed an innovative design with overlapping propellers (see figure 4), allowing us to use longer blades (14in or 36cm) whilst keeping the MAV narrow enough (61cm) to navigate in the sewers. These larger propellers, coupled with more powerful motors, deliver significantly more thrust, allowing for a larger payload capacity (1kg) and a longer flight autonomy (15 minutes).

The new platform also includes a fully rigid protection for the drone and the motors, and an enclosed space at the center where the onboard PC, the autopilot and other components can be mounted and protected from sewage water or dust.

Figure 4: Phase III MAV platform design

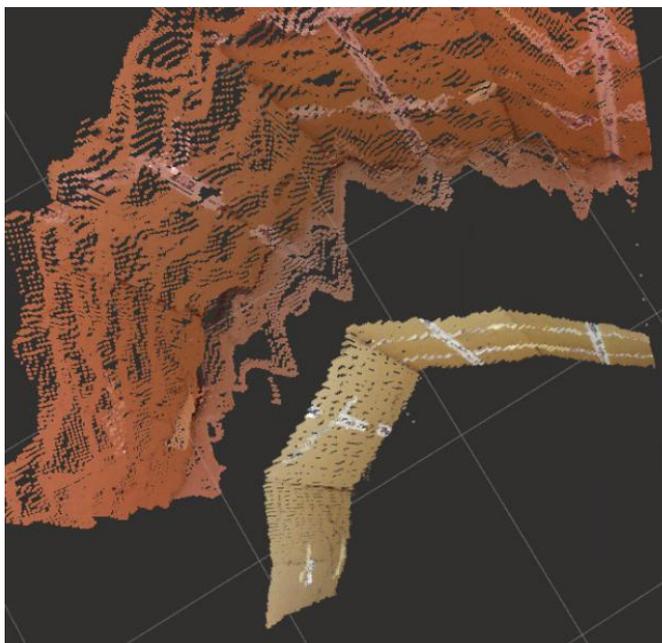
However our laboratory tests showed that the RGBD data produced by the Realsense was of poor quality compared to that of the Orbbec. Figure 6 shows RGBD point-clouds for the same object (a wall of cardboard boxes) generated by the Realsense (in the back) and the Orbbec Astra (at the front) in a well-lit environment and at a range of around 1m. We can clearly see that while the front point-cloud accurately represents the geometry of the scene, the other is heavily distorted. The Realsense data was even poorer at larger ranges or shallower incidence angles.

Figure 6: Comparison of point-clouds generated using the Realsense D435 (back) and the Orbbec Astra (front)

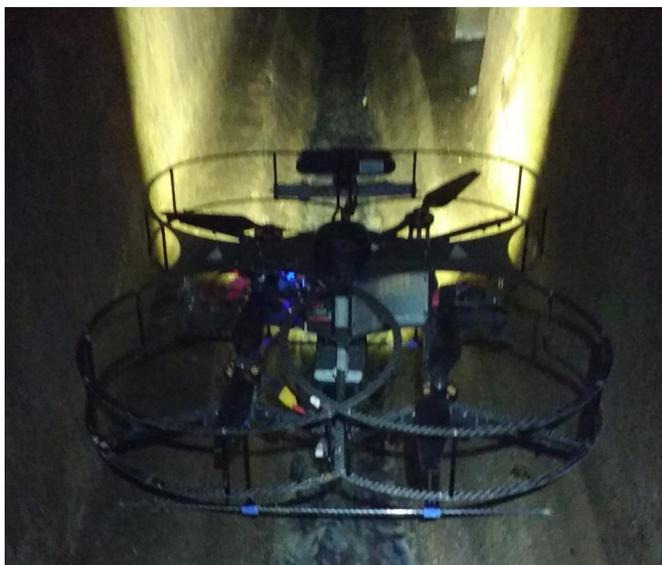
Figure 8: MAV before takeoff in a T111 section (see figure 20) at Plaça Virrei Amat. The section is 60cm wide at ground level (same as the MAV) and ~ 80 cm wide at flight altitude

Both in Plaça Sol de Baix and in Virrei Amat, several sewer sections exhibited smoother walls and cleaner surfaces than we had seen in Mercado del Born, offering very few visual features for the visual odometry algorithm to detect and track. This meant that the real-time velocity estimate was generally quite poor, and the MAV would struggle to control its speed. We frequently saw it lose odometry and fly at very high speed (as observed in the onboard camera), becoming very difficult to control.

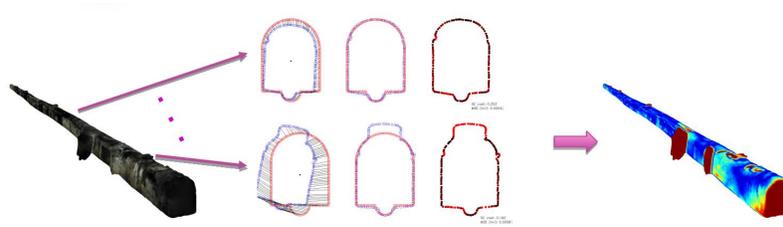
Figure 10 shows an overview of these steps.

Figure 10: Structural assessment starts by registering the sewer’s theoretical profiles with the reconstructed model (left & middle). A distance map is then computed to find variations along the course of the sewer (right), here shown as a temperature map.

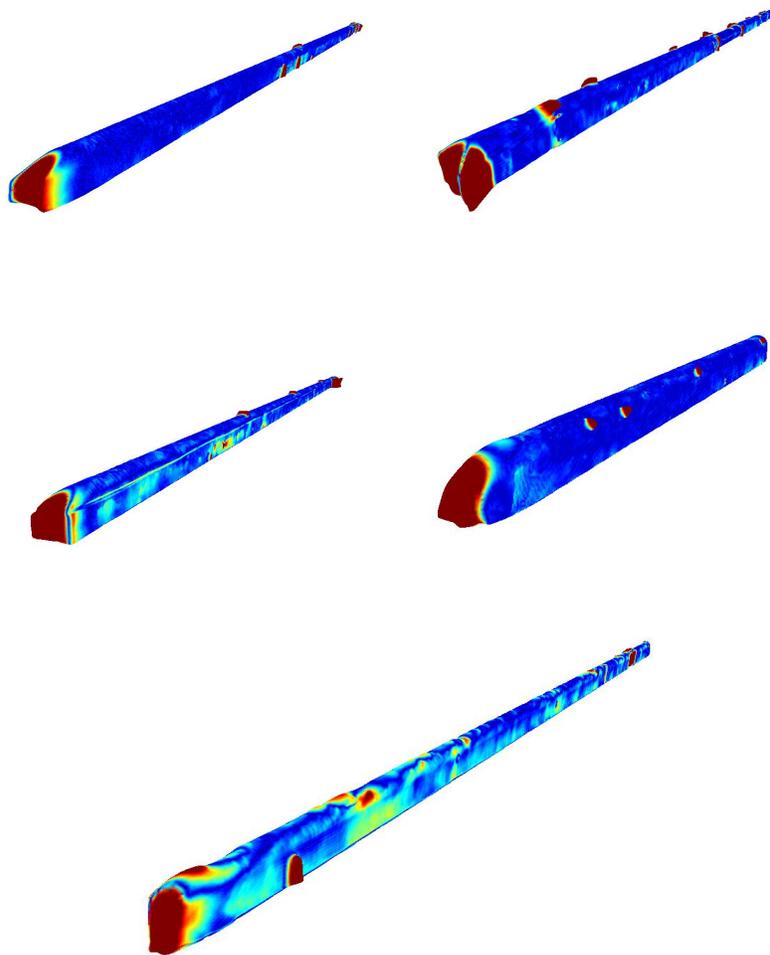
Figure 12 shows different sewer models reconstructed and processed with our approach. Distance maps are displayed as heatmaps, where blue means low difference/distance against the theoretical profile and red means high difference. Structural elements such as manholes and junctions are clearly distinguishable in red.

Figure 12: Distance maps computed on different sewers from Mercado del Born and Plaça Virrei Amat.

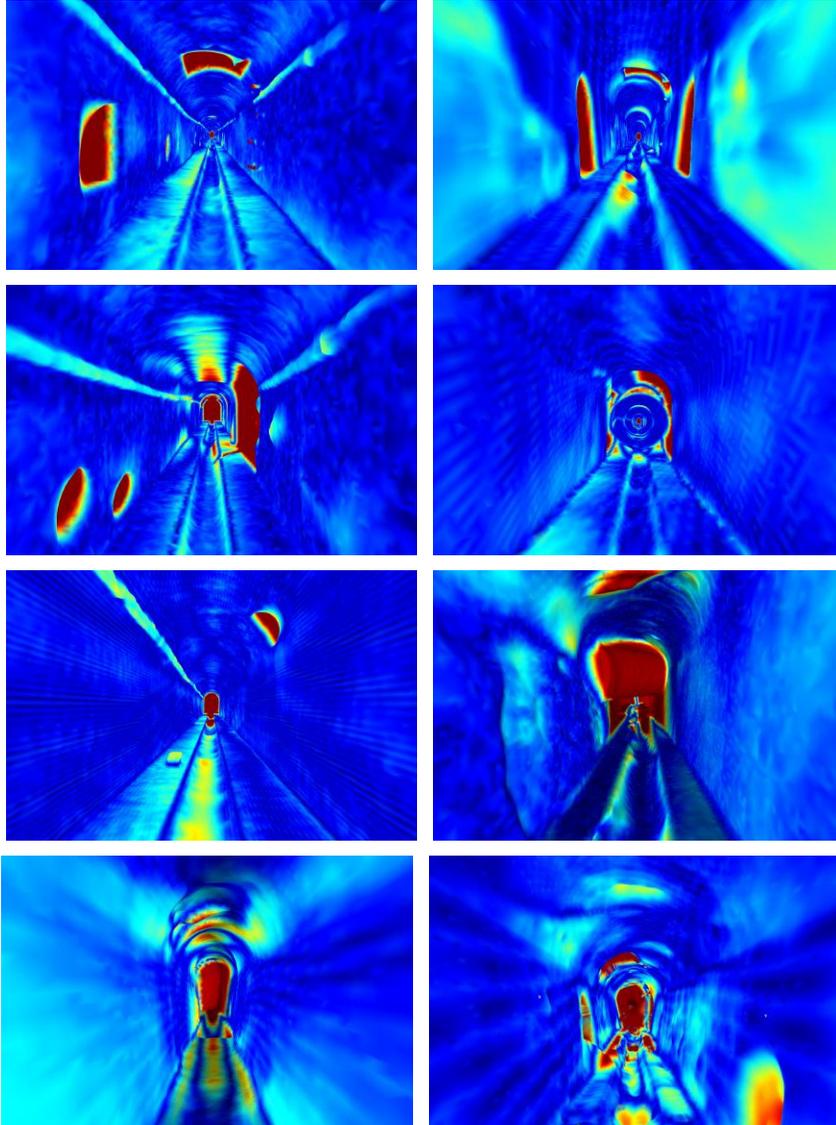
Figure 13 shows close-up views from the inside of the sewers. Top row depicts structural elements such as manholes (left and middle-left), gutters (middle-left), junctions and connections (left and middle-right) and profile changes (right). Bottom row shows obstacles in the form of stones (left), pipes (middle-left), and deposited material (middle-right and right).

Figure 13: Several examples of structural elements (top) and obstacles (bottom) present in the analyzed sewers.

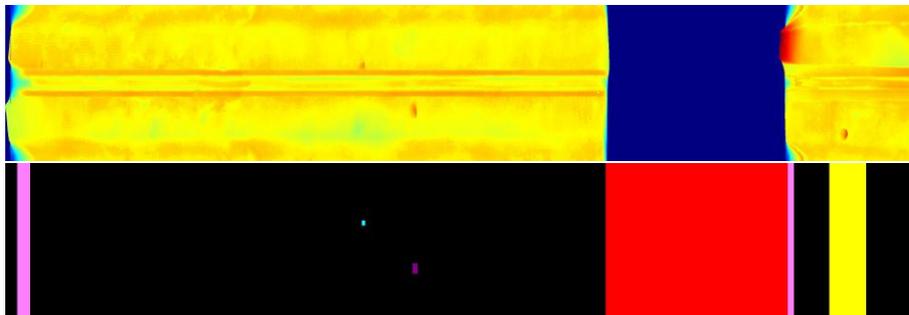
Figure 14: A texture image and the corresponding detection of structural elements and obstacles.

Figures 14 to 17 show different texture images for different reconstructions and their corresponding detection of structural elements and obstacles. The color legend is as in Table 1.

The detections are mostly correct. There are very few false positives. When there is one, it is mainly because it is close to a reconstruction error. False negatives are always because of overlapping regions.

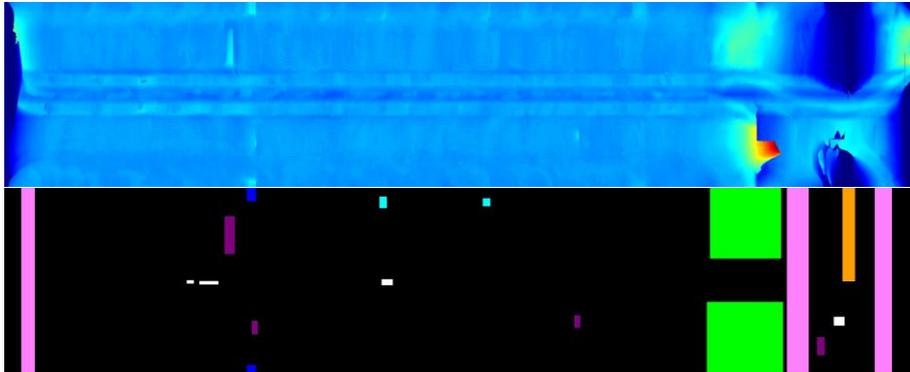
Figure 15: A texture image and the corresponding detection of structural elements and obstacles.

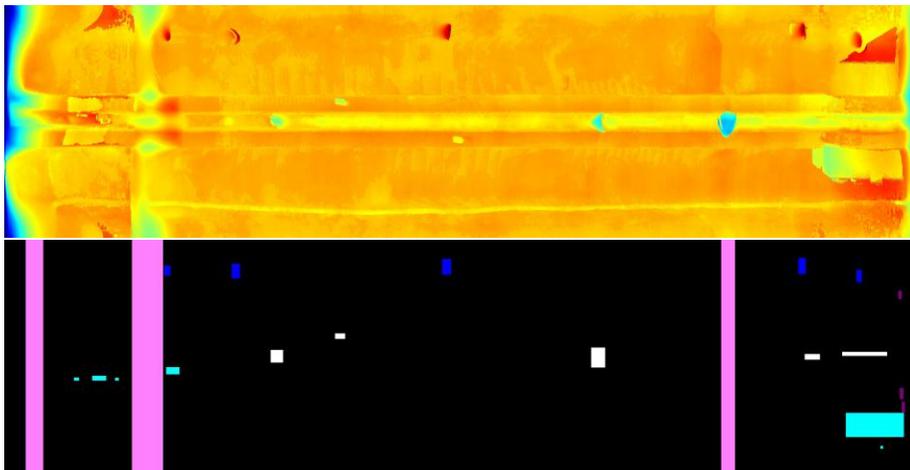
Figure 17: A texture image and the corresponding detection of structural elements and obstacles.

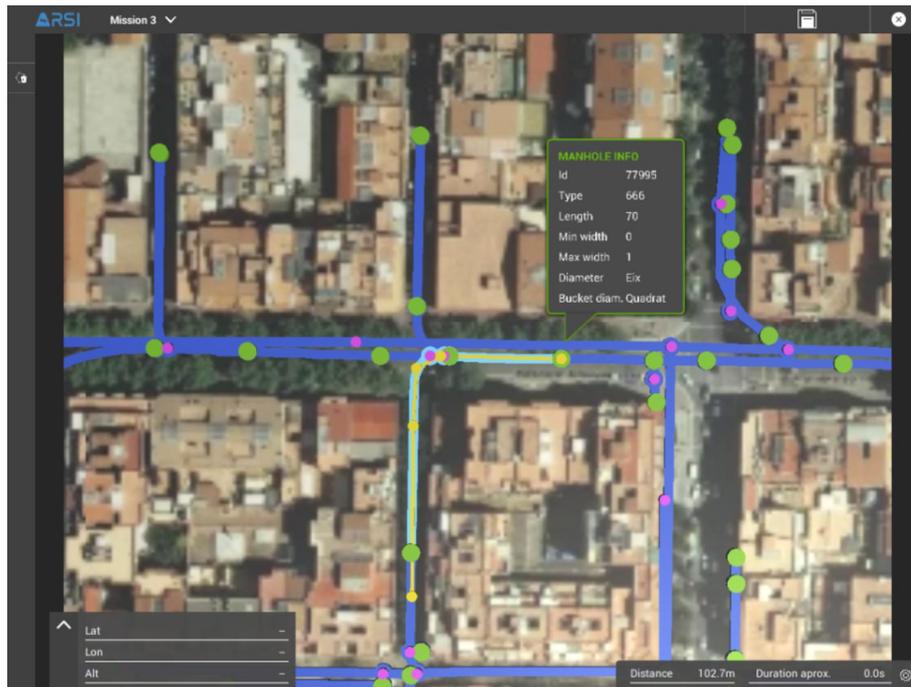
Figure 18: ARSI Mission Planner interface

A Mission Planner interface (see figure 18) was developed during phase III, allowing ARSI users to load GIS data and satellite imagery for the area selected by the client, and to plan a series of flights with the ARSI MAV to collect inspection data for the relevant sewer sections.

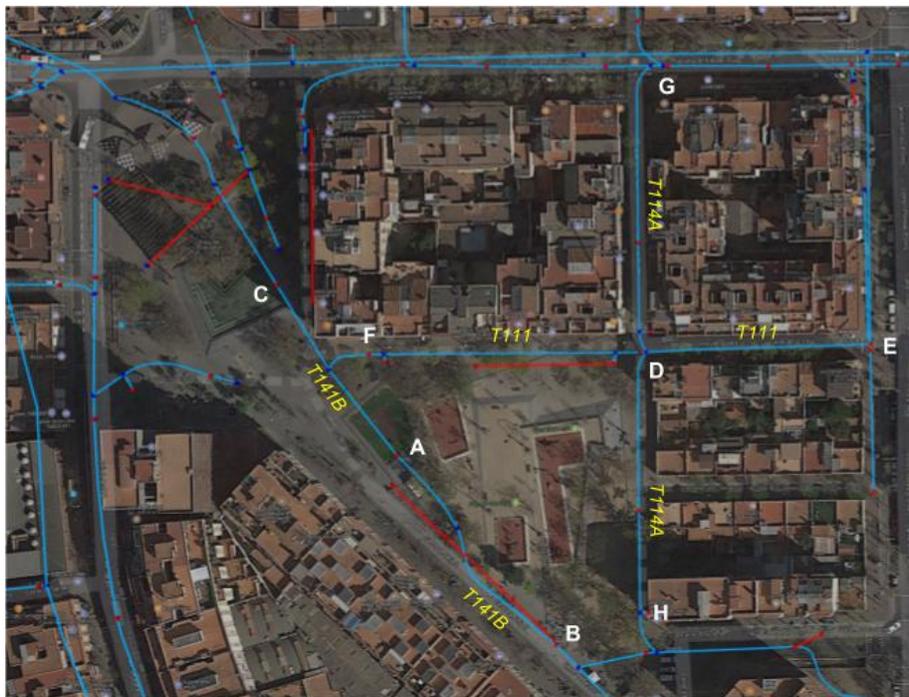
Figure 19: GIS data for the Virrei Amat area (Barcelona) with sewer sections (blue polylines), manholes (red points) and singularities (blue points). Red polylines represent sewer sections that are too narrow (<70cm) to be inspected with the MAV

At the July evaluation, we demonstrated the Mission Planner by loading GIS data of the Virrei Amat area provided by BCASA (see figure 19) and by planning a series of missions with the ECHORD evaluators. Once reviewed, the mission files were copied onto a pen drive and passed to

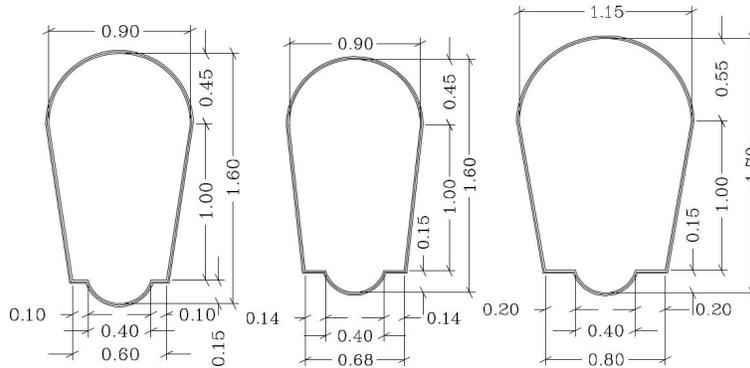
Figure 20: Sewer section types encountered in the Virrei Amat area. From left to right: T111, T114A and T141B

Given the geometry of a specific section (see for instance figure 20), we need to register its shape along the reconstructed sewer to detect any variations from this. At the same time, we need to detect locations where the section might change to the subsequent one, in order to always find differences with the appropriate section and check whether these locations coincide with the GIS information.

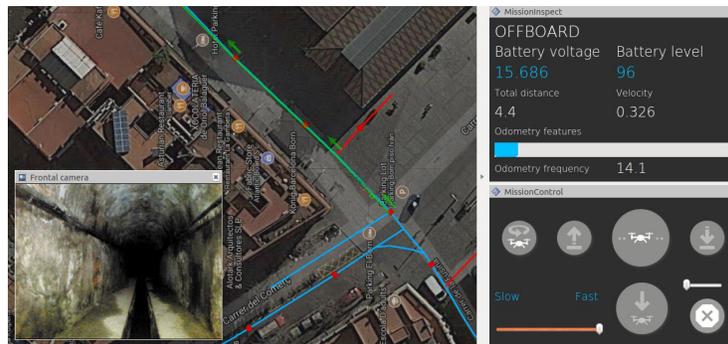
The Operator Console is the user interface used by inspection brigades on the field to carry out sewer inspections. It was significantly upgraded in phase III: the interface used for the July evaluation featured GIS data display of the sewer networks along with satellite imagery (Google Maps or other map sources such as Mapbox or OpenStreetMaps). Operators could load ARSI missions into the Console, display them on the map and query the GIS data (eg. manhole depth, type of sections, etc.) to plan operations before execution.

Figure 21: ARSI Operator Console with GIS and map display, live video feedback, and control panels

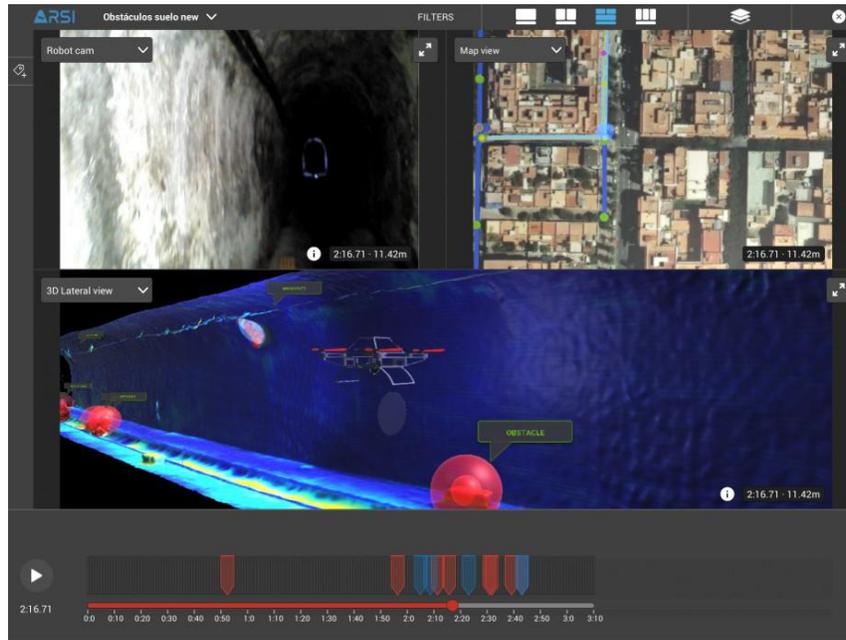
A new heatmap based visualization mode has been included, which offers to the operator a faster and intuitive way to recognize defects and potential conflictive areas.

Figure 22: Data Analysis Interface. Heatmap visualization mode

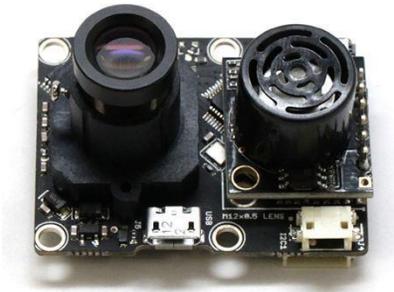
Figure 23: PX4Flow optical flow sensor for the Pixhawk autopilot
