Sewer **i**nspection **a**utonomous **r**obot

D28.12 - Structural Inspection

SIAR Consortium

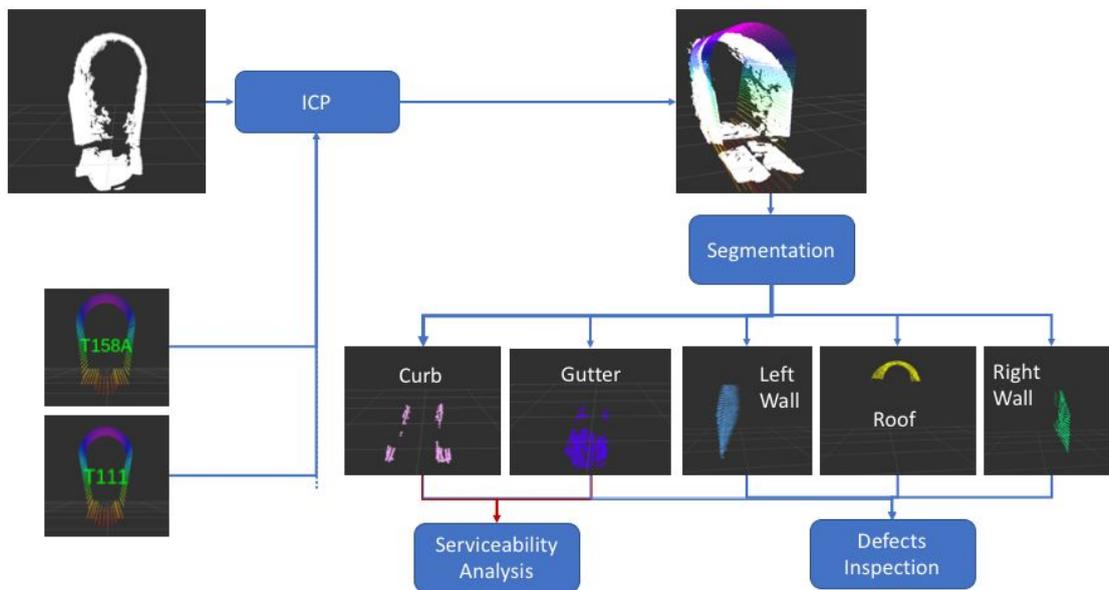
Figure 2.1: Main processing pipeline. ICP is used to estimate (and align) the current section type by comparing the 3D data (in white) with virtual models from the database. Then, the parts (curb, gutter, walls, roof) are segmented from the input point cloud. These parts are analyzed to estimate potential serviceability alarms (as described in D28.10) and defects.

Figure 2.1 summarizes the processing pipeline. The next sections detail these steps.

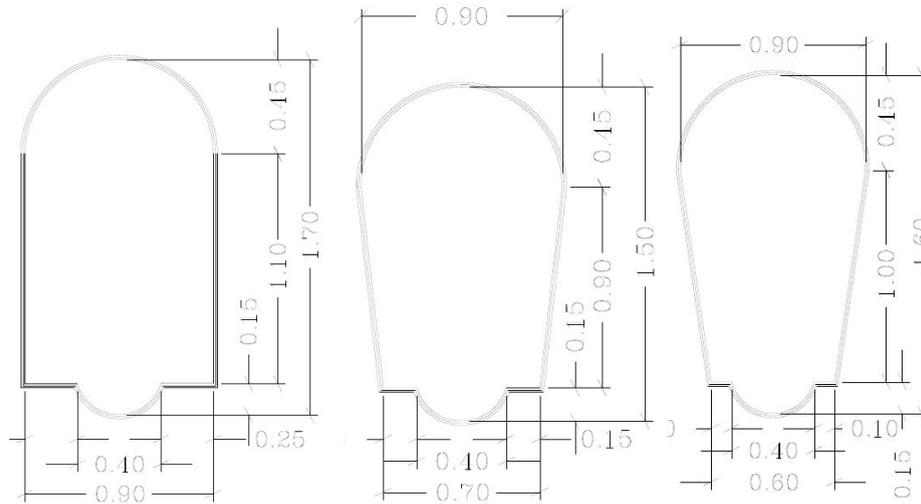
Figure 2.2: Different definitions of section types. Left: T135B. Center: T108. Right: T111

The robot stores a database of 3D virtual models of the different section types, according to the drawings of the different sections as provided (see Figs. 2.2 and 2.3). These virtual models also contain labels for the different parts of the sewer: gutter, curbs, walls and roof.

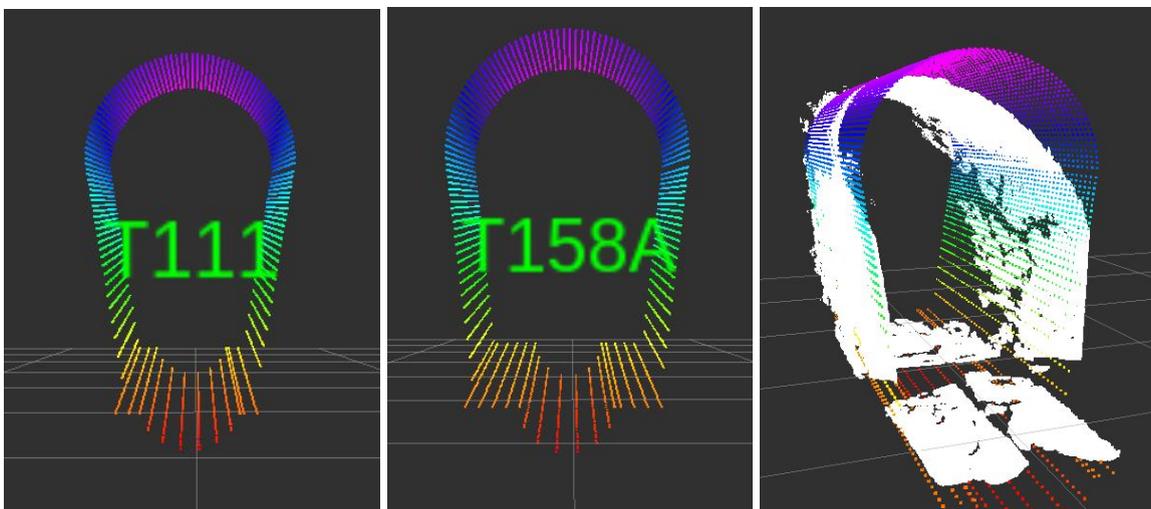
Figure 2.3: Left and center: Virtual ideal 3D models for section types T111 and T158A. Right: the current 3D data (white) is aligned using ICP to all the models in the database searching for the one that best fit the data.

The procedure to determine the section type is based on the Iterative Closest Point [Besl and McKay, 1992] algorithm. The current sensor data is matched, using ICP, to the different virtual models of the sections (see Fig. 2.3, right). To initialize ICP, the virtual model is created approximately aligned to the optical camera that provides the 3D data. The section types are ranked according to the residual of the alignment between the real data and the virtual model. The section with the lowest residual is selected as the current section type.

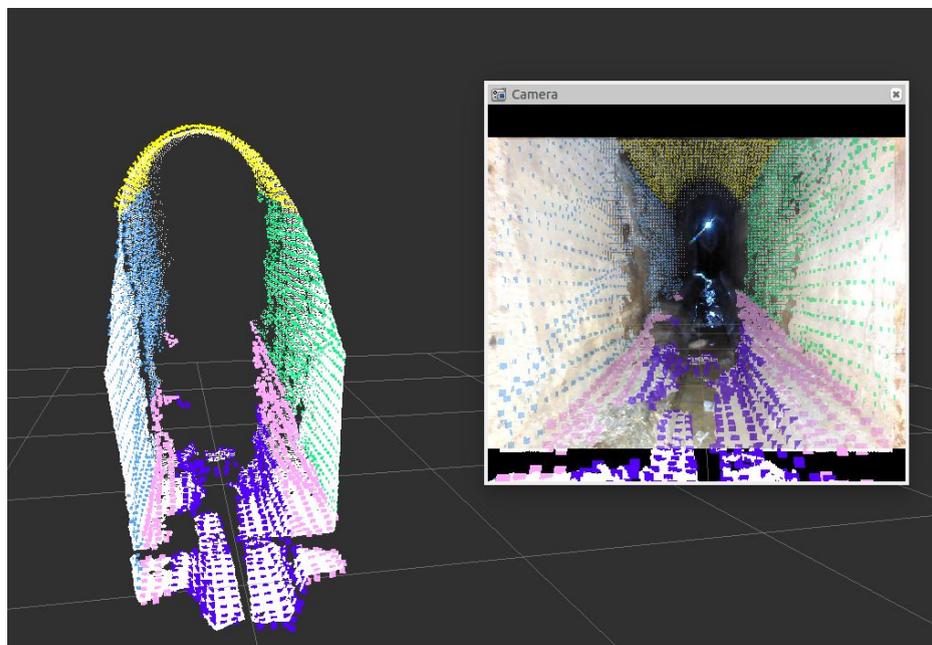
Figure 2.4: Point-cloud segmentation. After the alignment with the section, the points are segmented according to the different parts of the sewer. Left: points segmented as gutter (purple), curb (pink), left wall (blue), right wall (green) and roof (yellow). Insert: the points projected back on the frontal camera of the robot.

the closest point in the virtual 3D model of the sewer. Figure 2.4 shows the results of the segmentation.

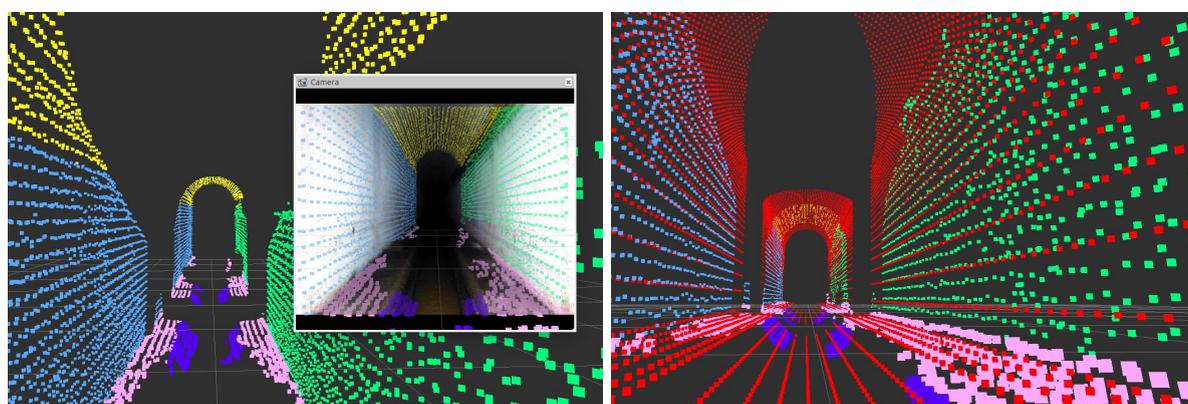
Figure 2.5: Left: the segmented point cloud. Right: the point cloud is aligned to the gallery virtual model (in red), according to the estimated most likely section.

Once the 3D data input has been aligned with respect to the section type and segmented into different parts (see Fig. 2.5), the structural defects inspection begins.

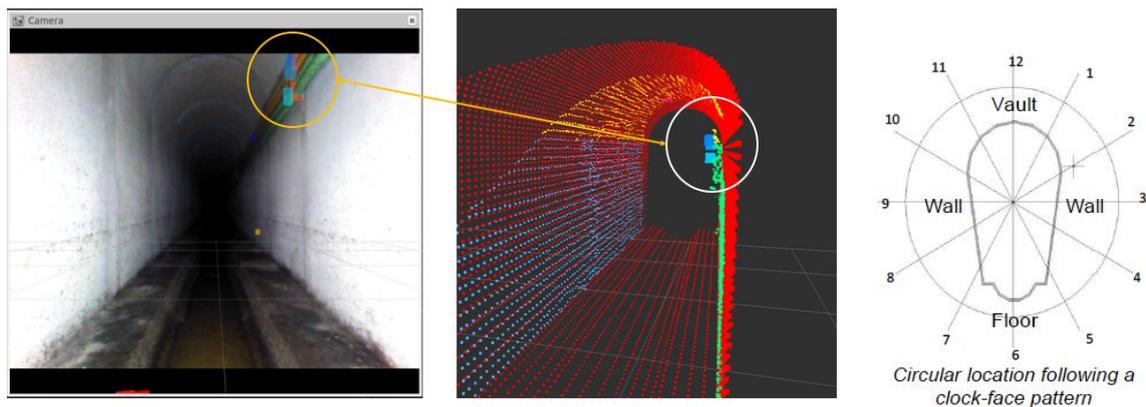
Figure 2.6: Left: the base station highlight a part of the image that deviate from the section model automatically estimated (T130 in this case). Centre: it can be seen how the points on the right wall and part of the roof (green and yellow) are misaligned with respect to the virtual model of the section (red). Right: as the 3D position of the points are known, it is possible to indicate the location of the defects following clock-face pattern.

Unfortunately, there has not been specific experiments to determine the resolution that the system can achieve when detecting small structural defects. To show the automatic detection of deviations between the sensorial data and the model, which can be used to raise potential failures, we have employed other features present in the environment and not in the model. Thus, Figure 2.6 illustrates how an element (an structure to hold cables) of some several centimeters can be detected as it deviates from the detected section type T130.

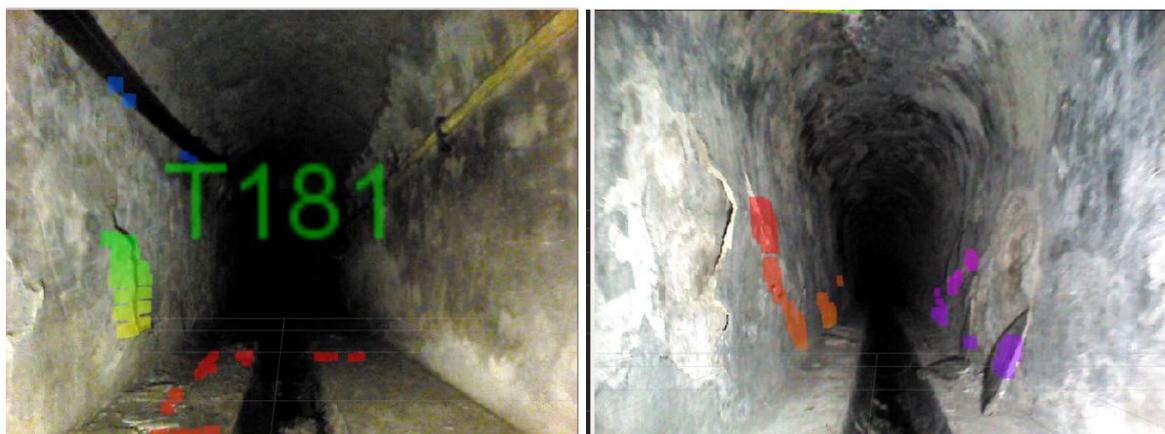
Figure 2.7: Defects detected using data from Phase II experiments.

Using data from different experiments carried out in the project, the approach has been able to detect some defects on sewers by using the system described in preliminary stages (see Fig. 2.7).

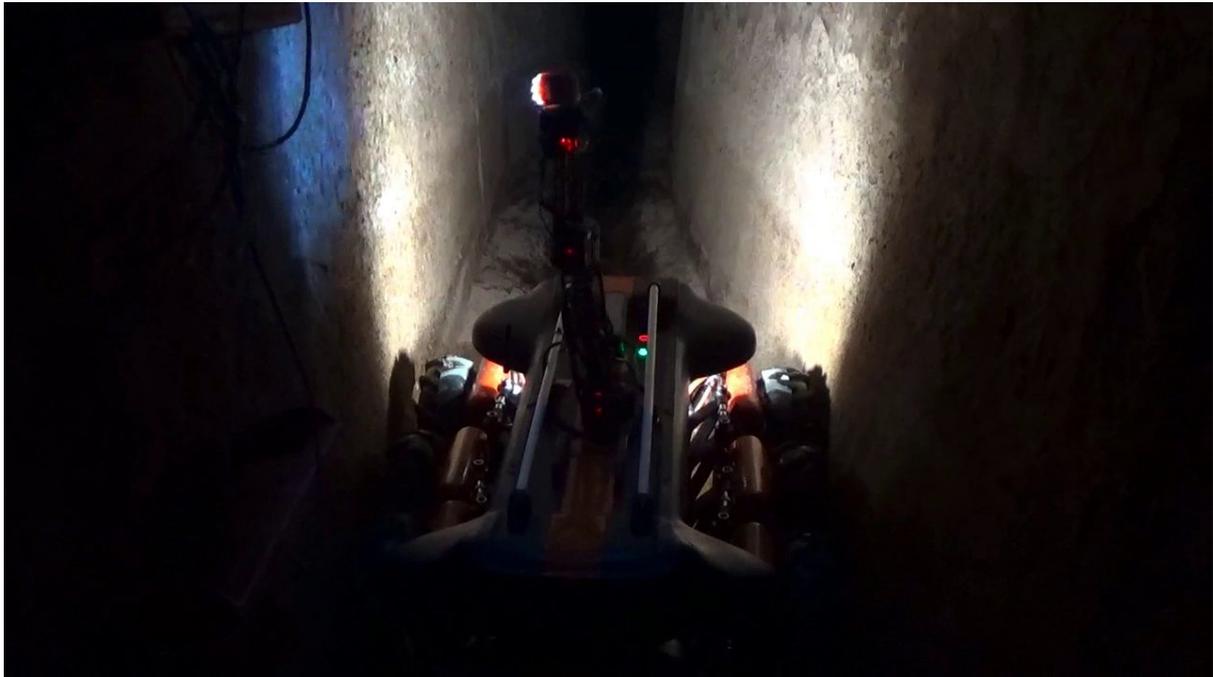
Figure 2.8: The robot now carries a camera on an articulated arm, that can be directed to the automatically-generated alarms for confirmation and close-inspection purposes.

SIAR carries now an arm with a camera onboard (Fig. 2.8), that can be used for close inspection and confirmation of the potential defects highlighted by the module.

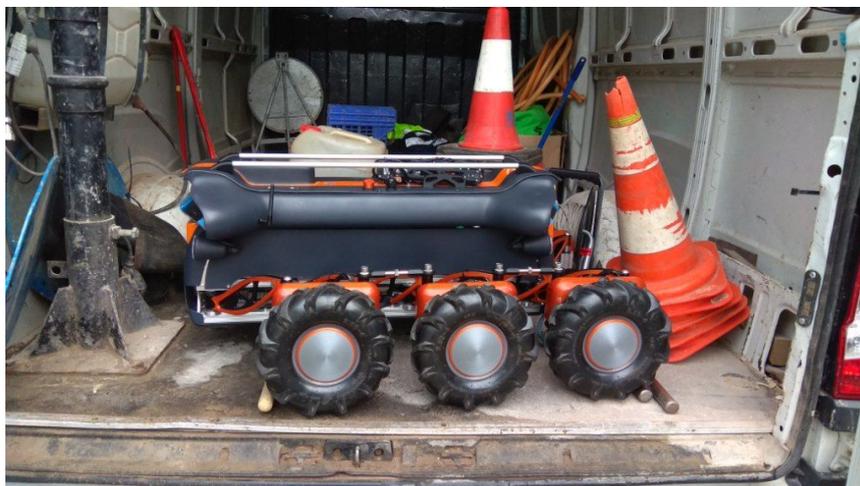
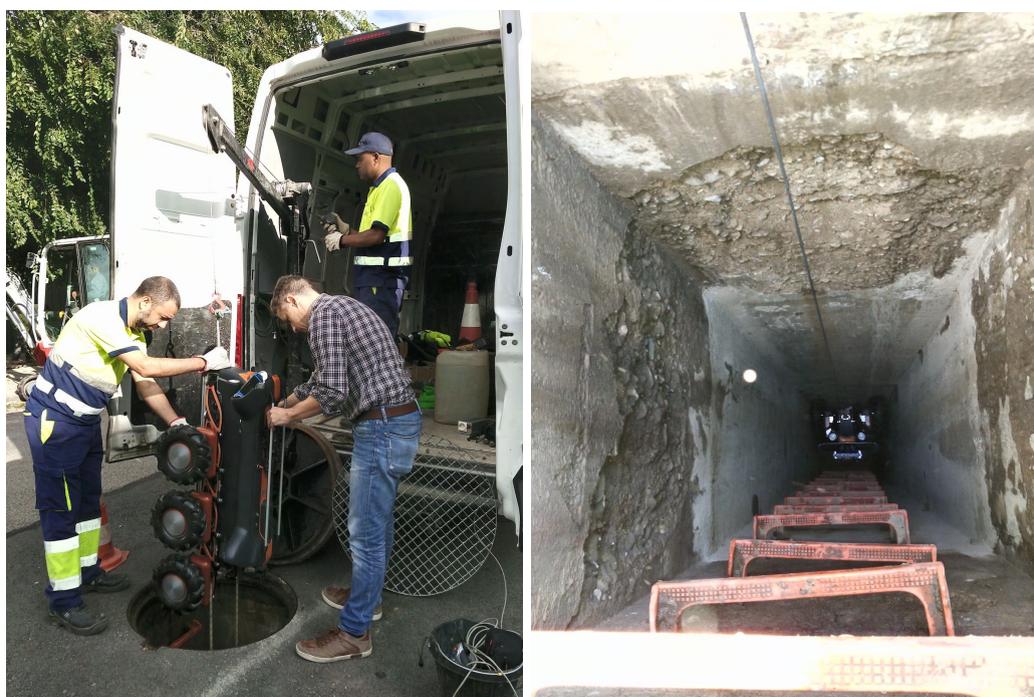
Figure 3.1: Top: the new SIAR platform on one of BCASA's vans. Bottom: the robot is deployed into sewer through a 10-meter manhole.

robot was deployed and commanded from outside using the control station (see Figs. 3.1 and 3.2).

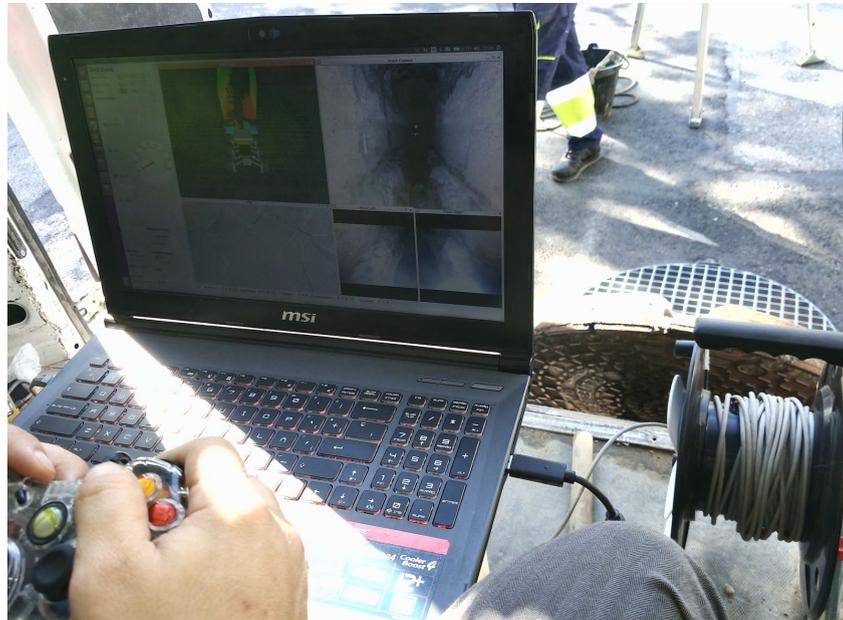
Figure 3.2: The robot is controlled from the Ground Station, which can run in a laptop, and shows visual and 3D information, including the view from the robot arm, as well as the automatically detected serviceability and structural defects alarms.

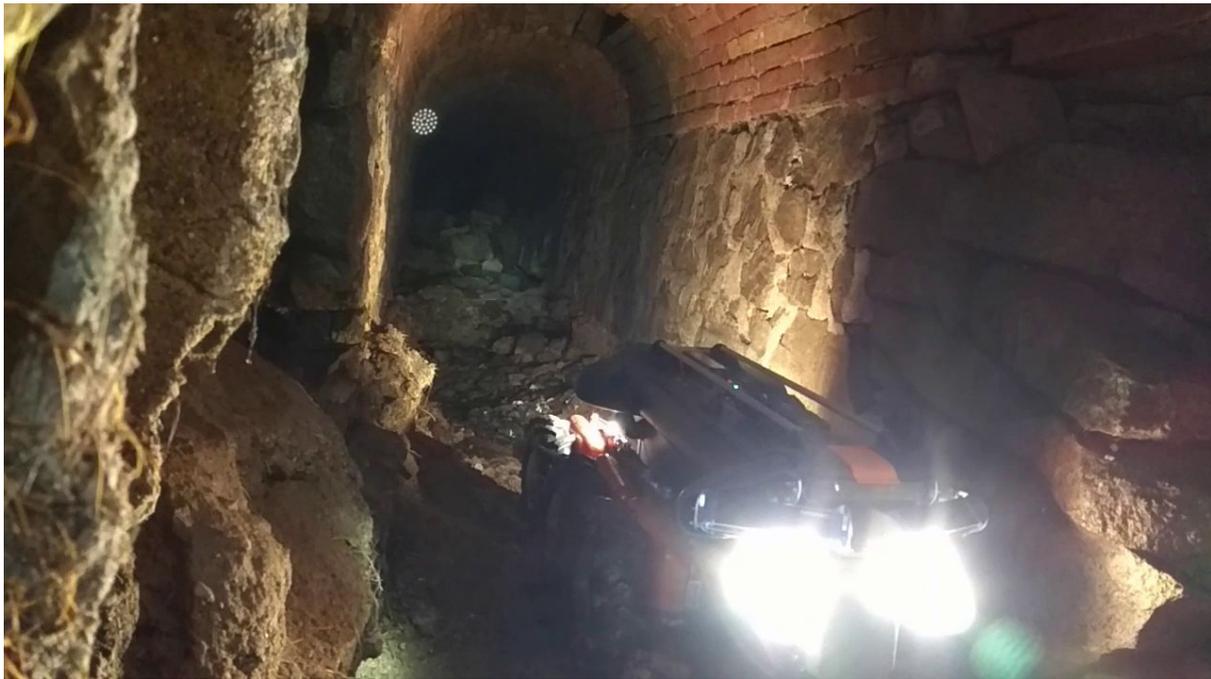
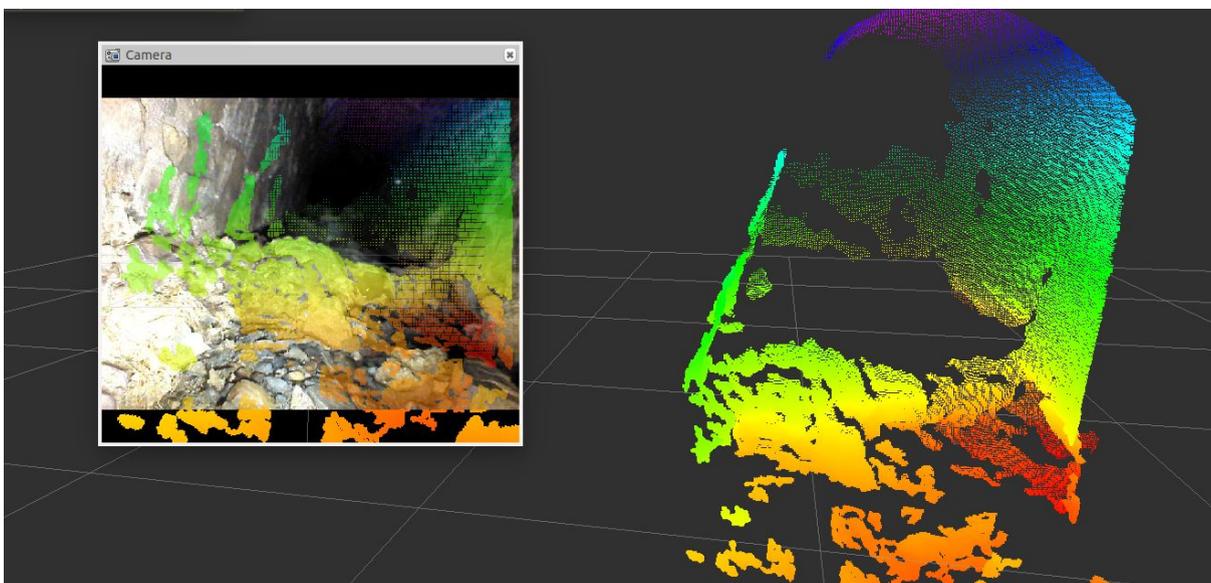
Figure 3.3: Top: a view of the robot entering the place where a collapse has happened. Bottom: the view from the frontal camera of the robot (left), and the 3D point cloud of the scenario (right, also overlaid on the image). The 3D information can see the blocks on the far part of the tunnel.

In the sewer, a major collapse was localized at the end of the inspected sewer. Figures 3.3 and 3.4 show the data about the defect, and the extracted information.

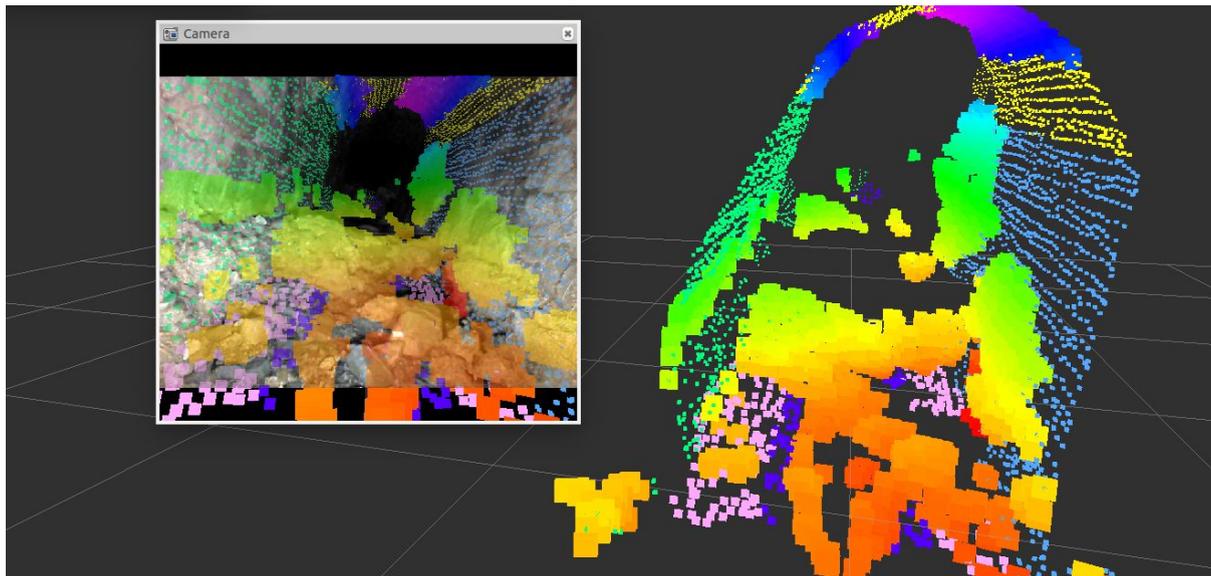
Figure 3.4: Automatic detection of potential defects. The method estimates a potential section type, even for such a damaged place, and highlight the different parts and potential defects on the floor and walls.

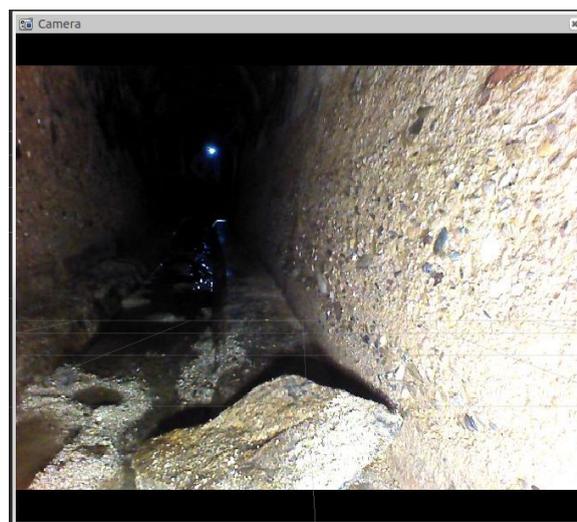
Figure 3.5: Automatic detection of a serviceability problem. The images gathered at the position where the alarm is raised show sediments and a big rock into the gutter.

A similar experiment was carried out on October 18, 2018. Besides the structural defect, a serviceability problem was also detected, due to sediments in the gutter and curb (problem that was not present during the experiments in Nov. 7). The problem is shown in Figs. 3.5 and 3.6:

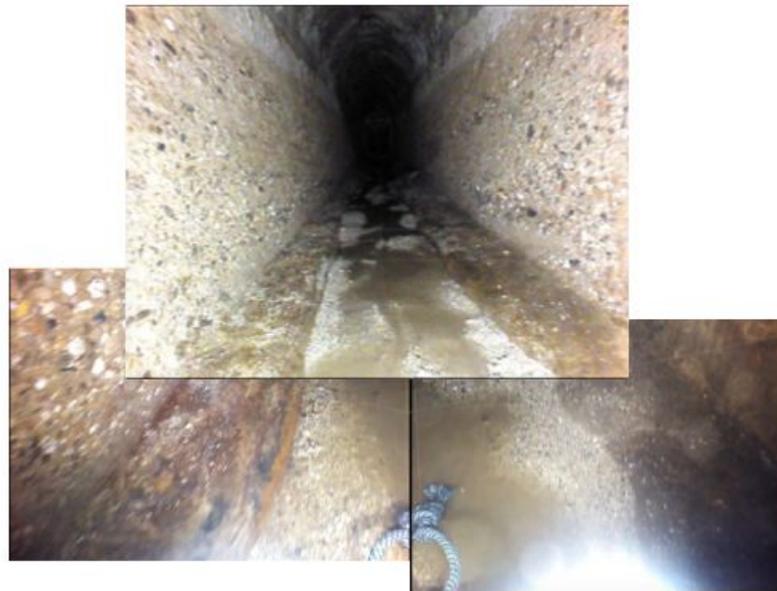
Figure 3.6: Additional images of the serviceability problem from the 3 cameras looking forward of the robot.
