Sewer **i**nspection **a**utonomous **r**obot

D28.9 - Changes and Improvements

SIAR Consortium

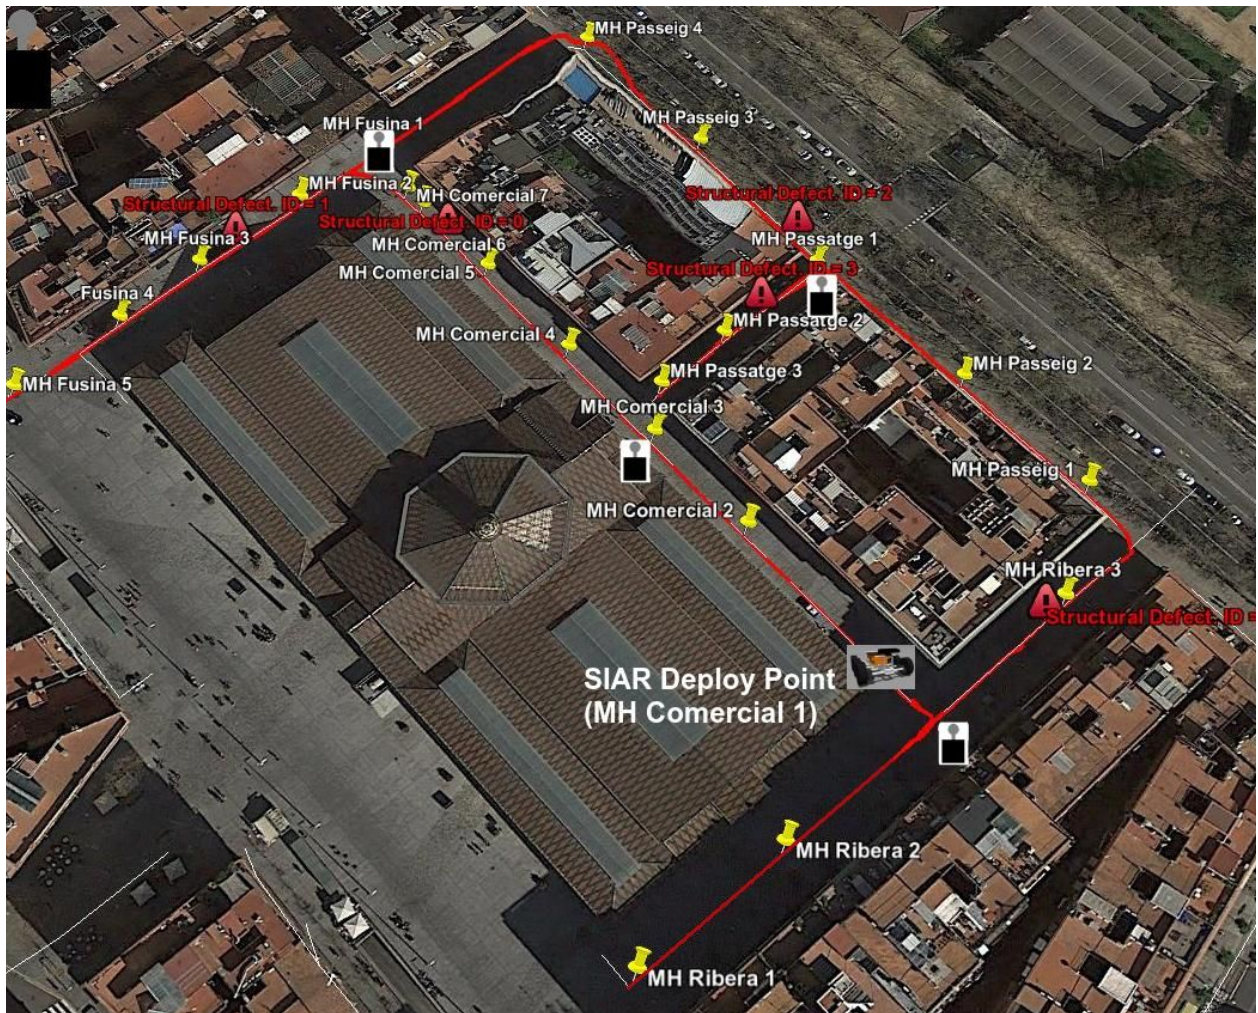
Figure 2.1: Trajectory of the platform (red line) and visited manholes (marked with yellow stickers) during the final demo of Phase II. Disposition of the repeaters with manhole deployment, depicted as black boxes with gray grippers. Reported defects found during the inspection marked in red exclamation signs.

Figure 7.2: Left: automatic detection of section type (T164) overlaid on the image and potential structural defects (a potential break with some losses). The information is provided in 3D, so it is possible to indicate the location of the potential defect according to the clock-face pattern indicated in the Challenge Brief (right). Given the localization of the robot, it is also possible to localize the defect on the map (see Fig. 2.1).

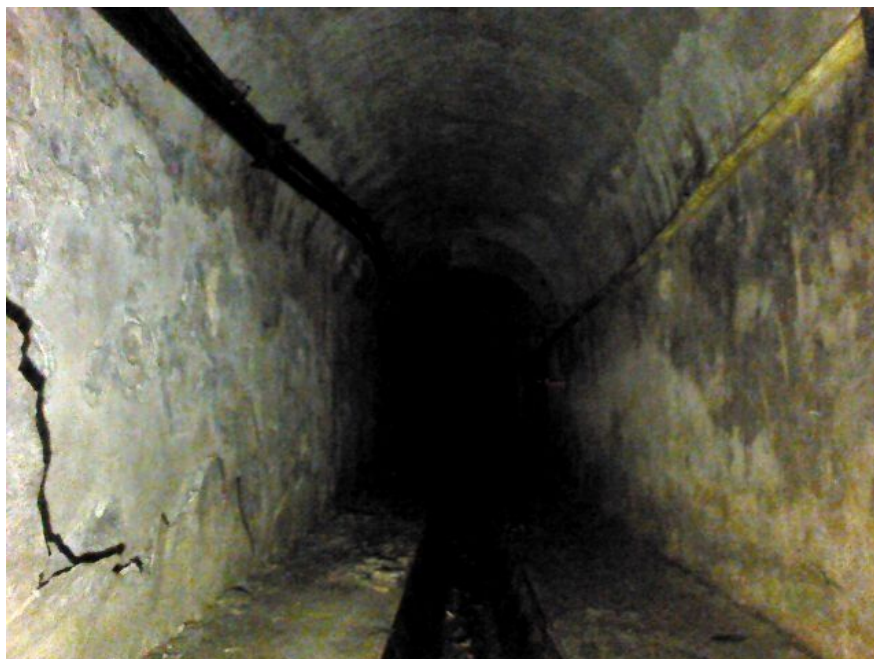
2.3.1 Alert ID 0

Approximate Location: 41.3864371269047°N, 2.1835667670244° E
Local Time: 2017-10-17 10:52:32

This alert was generated as evident defects on the left wall can be found, as well as sediments on the floor.

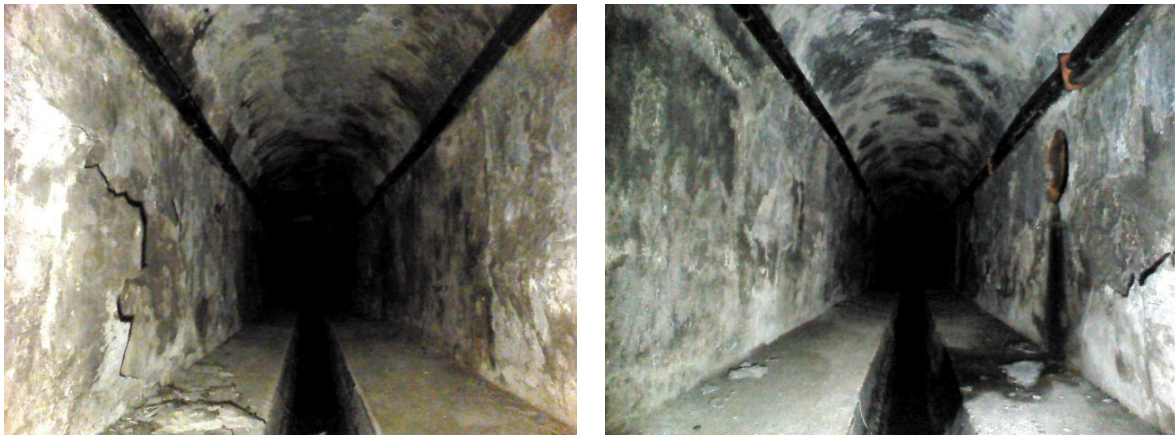
2.3.2 Alert ID 1

Approximate Location: 41.3863587638969°N, 2.18316345992166° E

This alert was generated as evident defects on the left wall can be found (right with the rear camera).

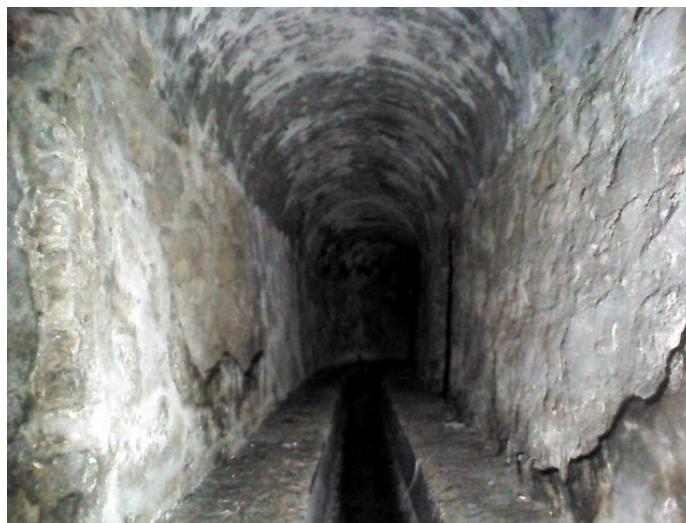
2.3.2 Alert ID 2

Approximate Location: 41.3864067159017°N, 2.18443510049748° E

This alert was generated as evident defects on the left wall can be found (right wall in the rear camera), as well as sediments on the floor.

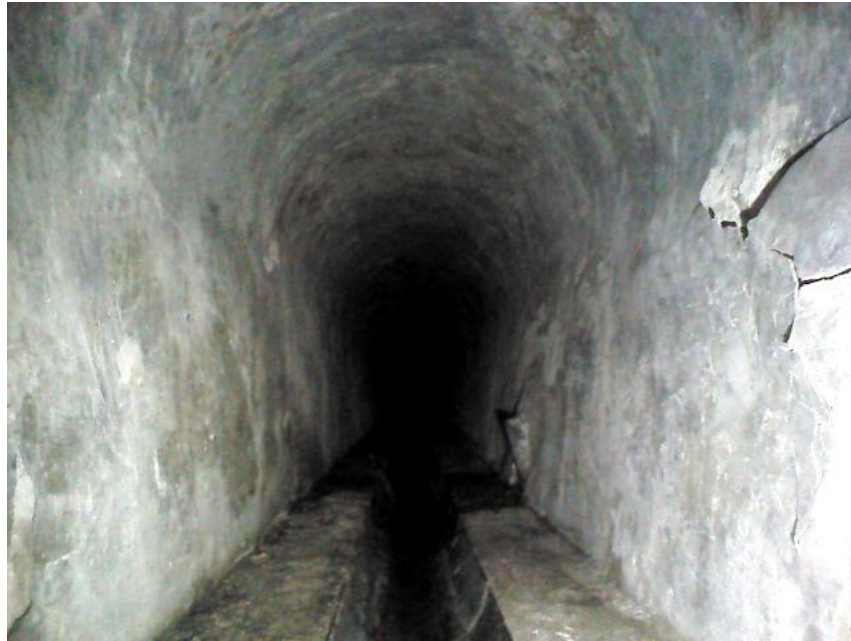
2.3.4 Alert ID 3

Approximate Location: 41.3862493148859°N, 2.18316345992166° E

This alert was generated as evident defects on the right wall can be found. Image obtained from rear camera.

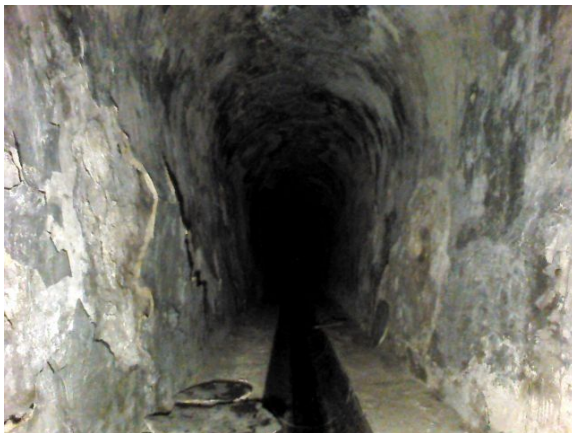
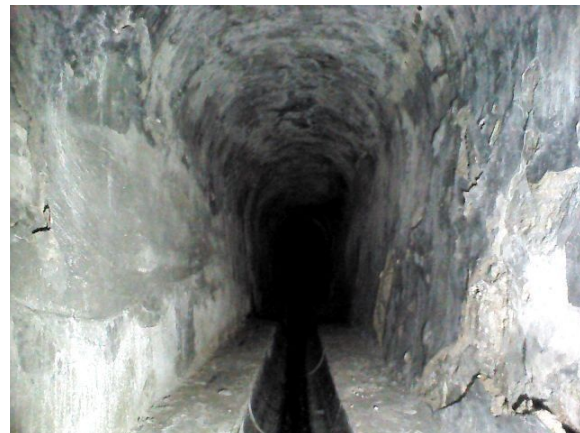
2.3.5 Alert ID 4

Approximate Location: 41.3856977498308°N, 2.18497454392256° E

This alert was generated as evident defects on the right wall can be found, as well as sediments on the floor. Image obtained from front camera (left) and rear camera (right).

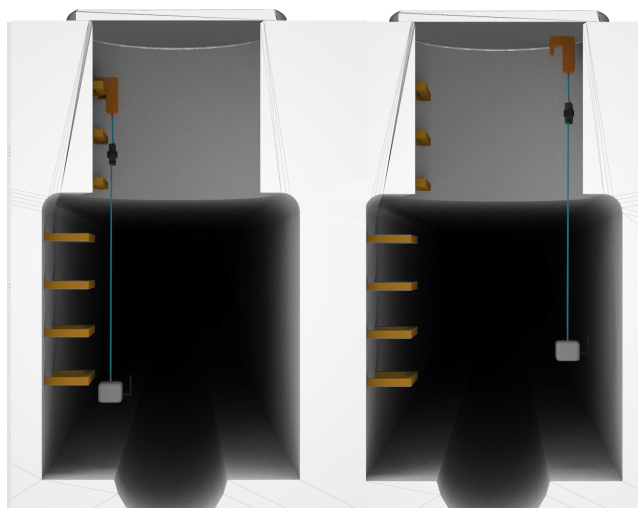
Figure 3.2 - Left: Installation of the repeater on the steps of the manhole.
Right: Installation of the repeater on the manhole cover;

reduced. Figure 3.2 on left shows the deployment of the repeater on the manhole steps, on the right shows the same repeater installed on the manhole cover.

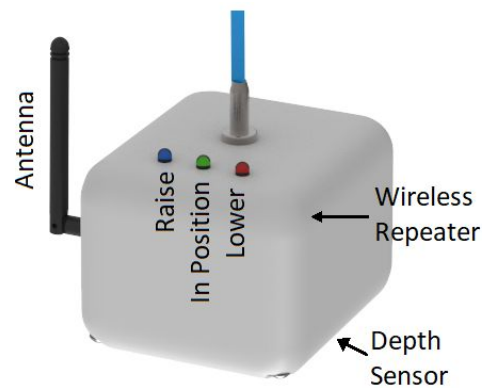
The bottom part, shown on Figure 3.3, includes a distance sensor and the wireless repeater.

Figure 3.3 - Repeater bottom part

The distance sensor is an unidirectional micro LIDAR with a detection range of 12m. This sensor will be installed on the bottom of the repeater box, measuring the distance to the sewer floor (not the gutter). The optimum position will be given by a small circuit board that will use the measured distance and activate 3 different LEDs. The blue LED indicates that the system should be raised, the red LED indicates that the system should be lowered and the green is activated when the system is in the right position.

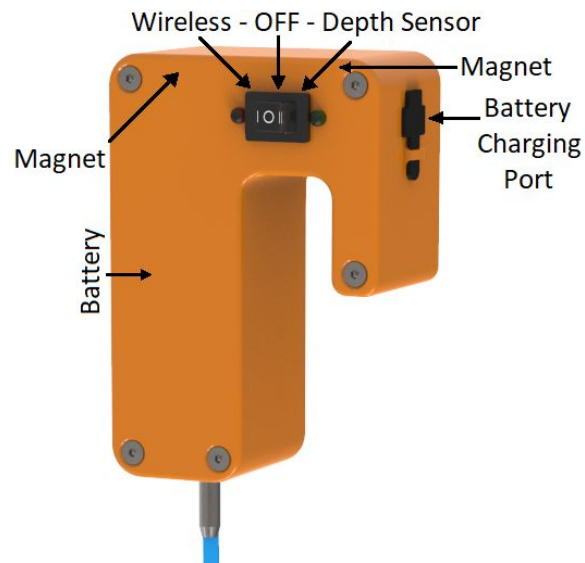
Figure 3.4 shows the repeater top part, which has a shape that allows the system to be hanged on the steps and two magnets on the top to alternatively fix the system to manhole metallic cover.

Figure 3.4 - Repeater top part

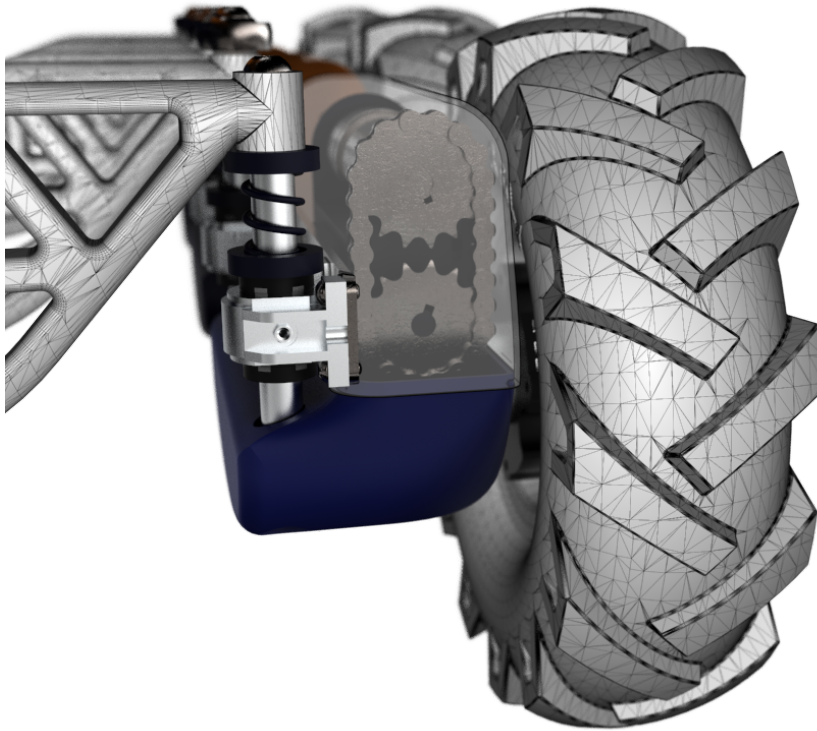
chain. The bottom of the worm gear wheel is now rounded to facilitate the slippage of the robot on the forks' gutter edges (Figure 4.1).

Figure 4.1 - Worm gear protection

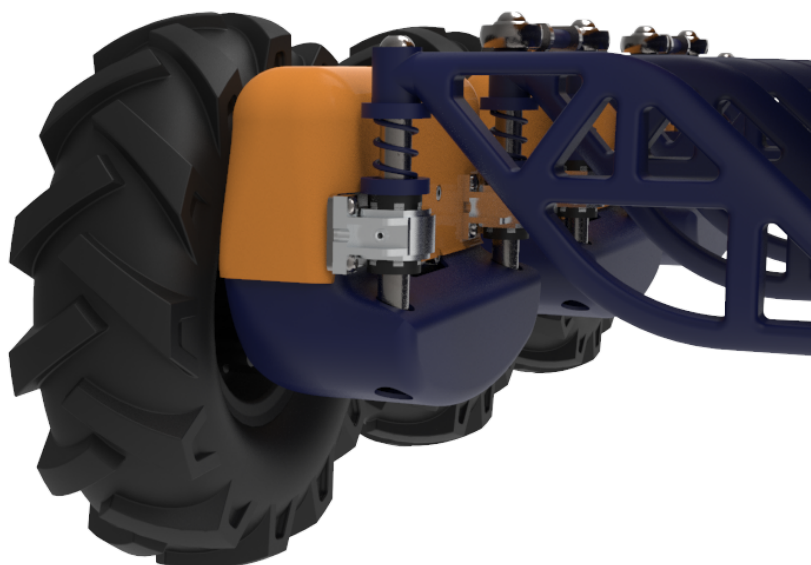
The connection between the worm gear box and the arms was inverted, with the linear bearings mounted on the worm gear box while the stainless steel rods with suspension springs are mounted on the wheel arms (Figure 4.2).

Figure 4.2 - New wheel and arms connection.

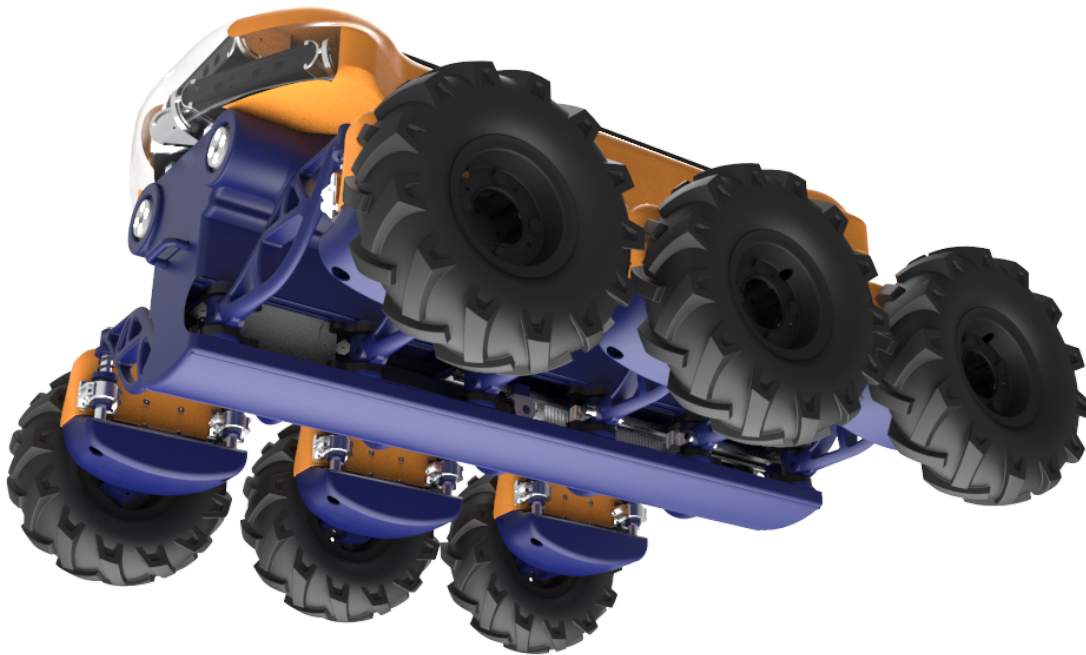
The linear motor was lifted to be installed between the middle of the bottom and the top central frame. The wheels' arms actuation is now performed in between the top and bottom central frames. This operation increases the central clearance to the floor while protecting these sensible parts.

Figure 4.3 - Wheel arms actuation.

The arms design and the way the linear motor actuates were then revised, creating a more attractive and robust system as shown in Figure 4.3.

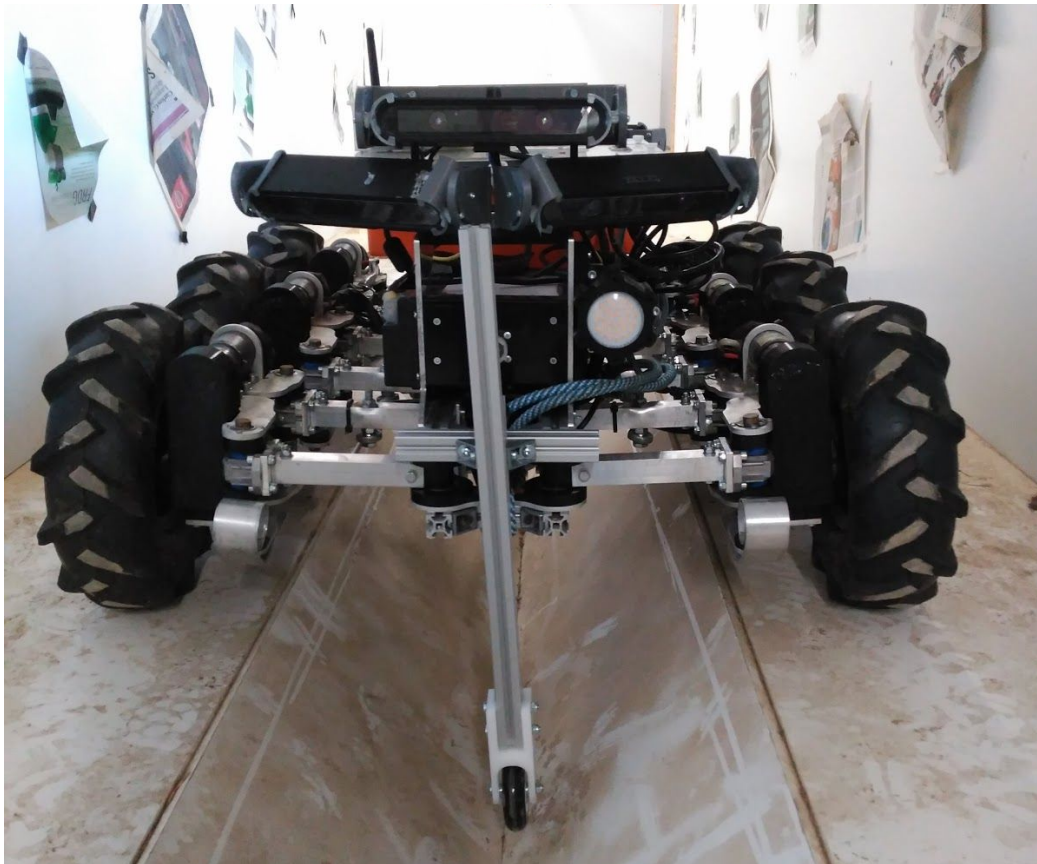
A first solution is composed by a front and rear wheel that will touch the bottom of the gutter (see Figure 4.4). This solution will maintain some pressure on gutter's bottom, maintaining the 6 wheels leveled with the horizontal. In the normal path without forks this system will be the guide of the center of the robot to the middle. If the robot starts to deviate, the pressure on these wheels will make the body to adjust to the center of the gutter.

Figure 4.4 - Photo of SIAR v3 using the first solution in UPO's sewer mock-up

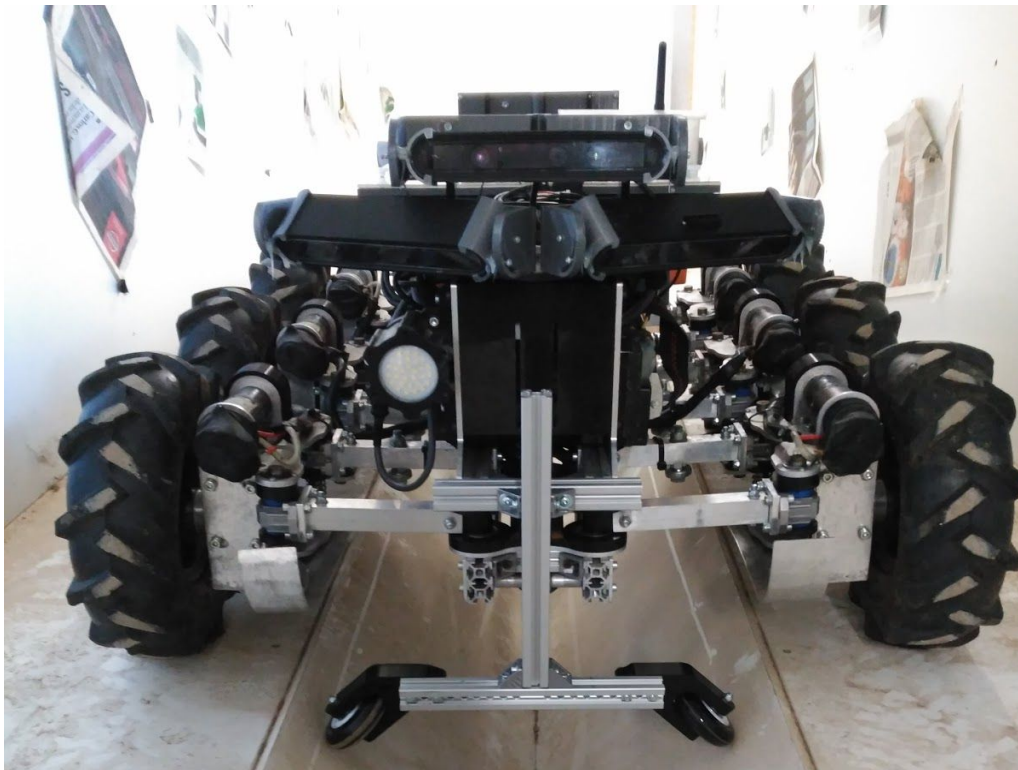
The second solution is composed by a set of two wheels mounted on the robot's front and rear (see Figure 4.5). This system will use the lateral sides of the gutter to limit the deviation of the robot from the center of the gutter. In the forks, the idea is to use these wheels to force the robot to go up, adjusting the position of the robot to the center of the gutter.

Figure 4.5 - Photo of SIAR v3 using the second solution in UPO's sewer mock-up

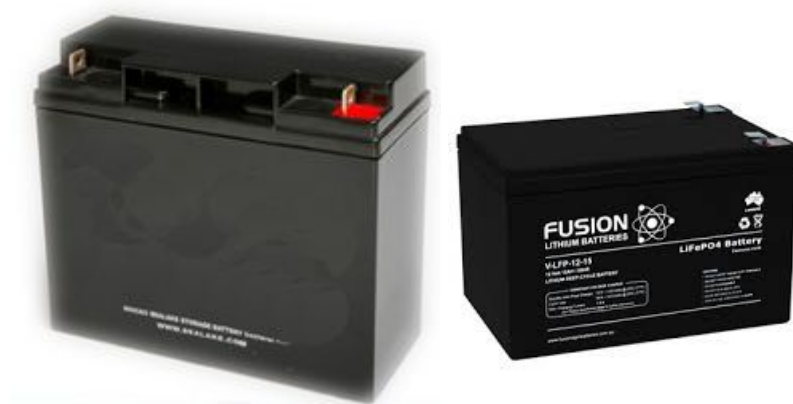
The current system uses two LiFePO₄ 12V 18Ah batteries. One of the batteries was used to power all the electronics and the other was used to power the motors system. With the increase of the processing power and sensors there was the need to increase the available power provided by the batteries. As so it was decided to change the battery size to smaller ones that better fit the new design. Meaning, the new design includes four LiFePO₄ 12V 15Ah batteries. Figure 4.6 illustrates the different sizes of the two batteries.

Figure 4.6 - Left: Old battery; Right: New battery.

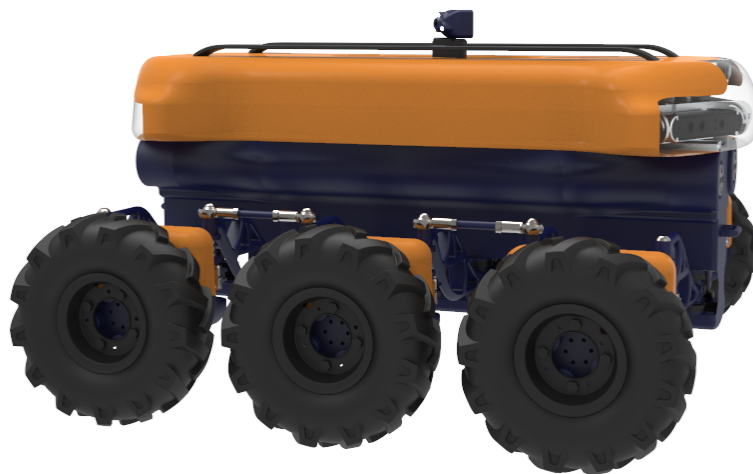
To be able to perform all of these tasks, it was decided to include a camera mounted on a simple robotic arm. This system will be mounted on the robot's top to increase the camera capabilities and to simplify the robotic arm movements. Figure 4.7 shows a simple inspection where the full arm does not need to be fully activated.

Figure 4.7 - Simple Inspection configuration

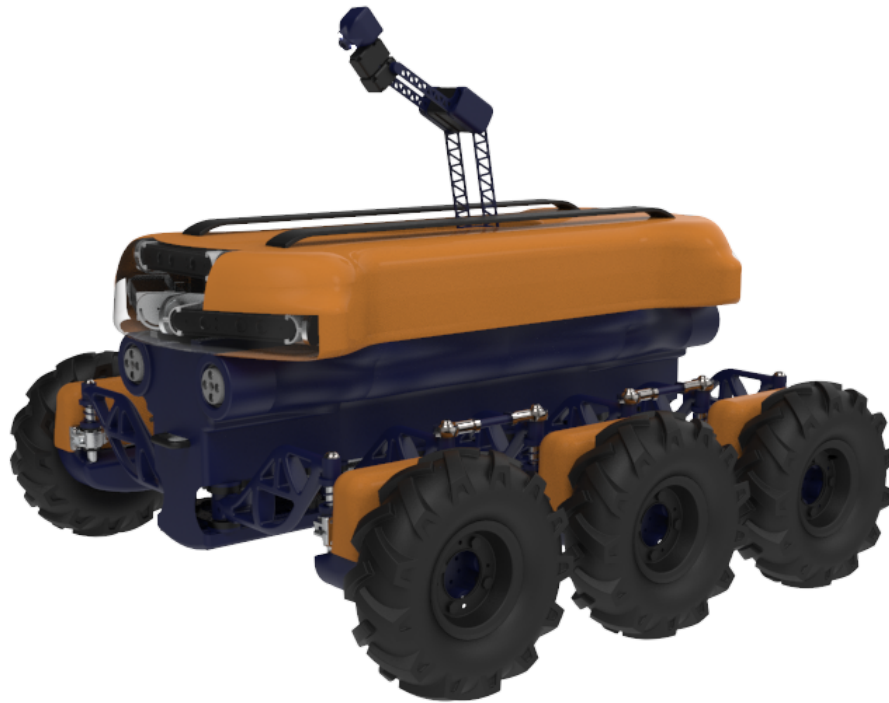
The robotic arm will have springs on the motor joints to provide some stability to the camera image while navigating on the sewer galleries. The same springs will be used to keep the robotic arm in a retracted position, while the robot is being deployed/retrieved from the sewer, or while not in use.

Figure 4.8 - Possible navigation configuration

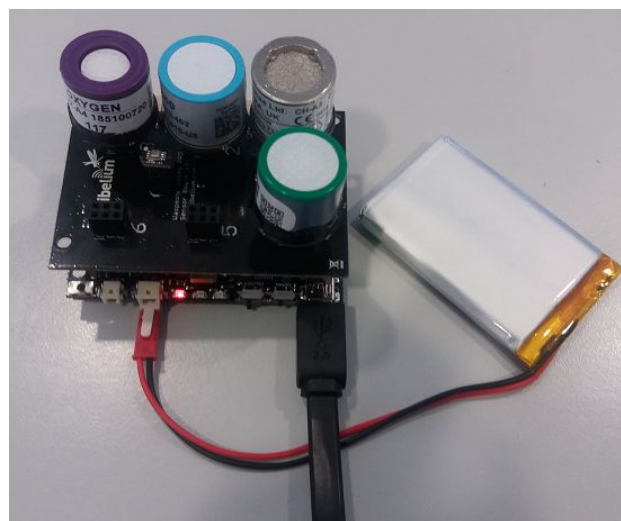
In Phase III the robot will be able to measure gases concentrations inside the sewers. For that purpose it was included a Waspnote Pro OEM gas system on the robot. Figure 4.9 shows the acquired Waspnote Pro system.

Figure 4.9 - Waspnote Pro OEM gas system

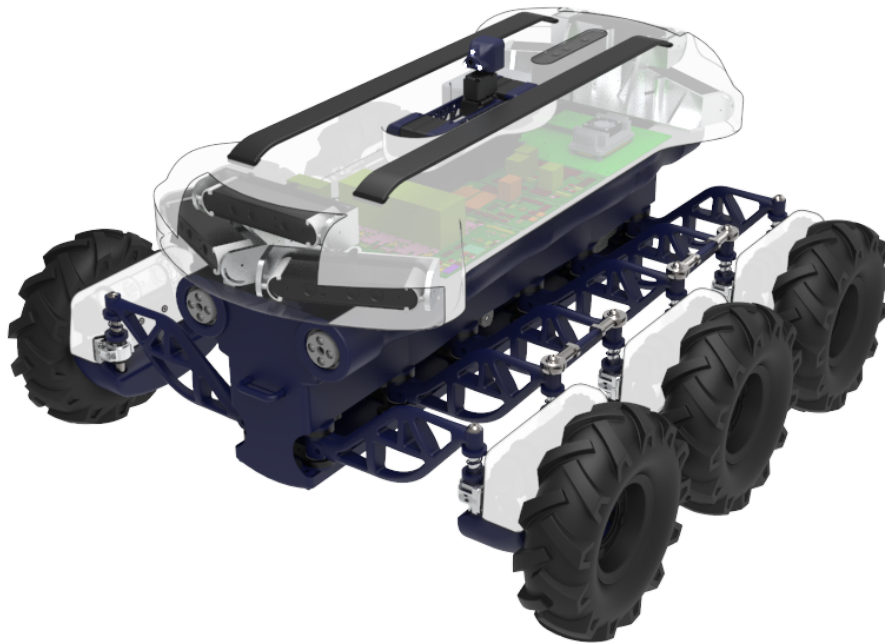
The robot design includes a protective shell, that protects all the electronics components, sensors, batteries, lights and motors (see Figure 4.11).

Figure 4.11 - Electronic components position inside the robot.

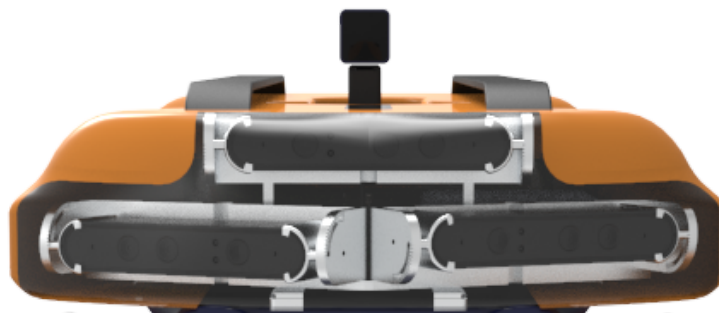
The RGBD cameras will be installed under a protective transparent polycarbonate that will protect them against the falling water and contact with the sewers walls (see Figure 4.12).

Figure 4.12 - RGBD cameras protection

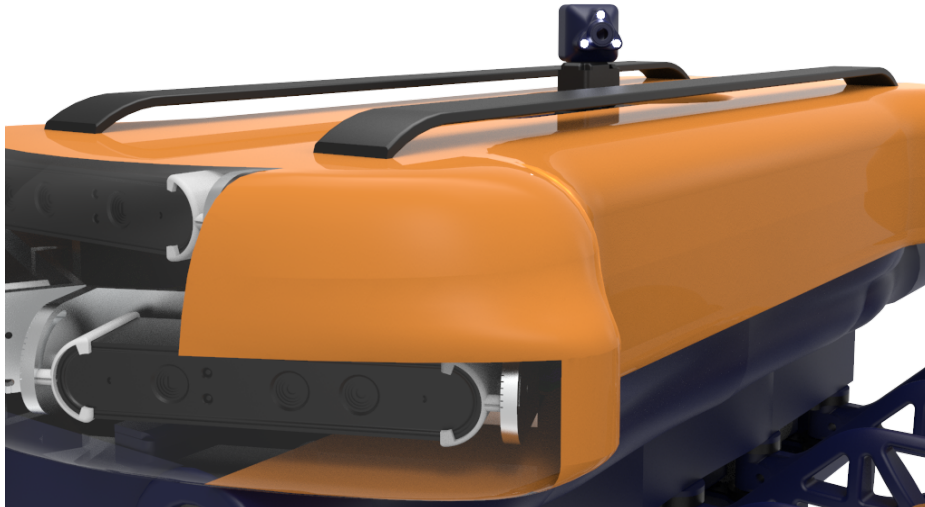
On top, two aluminium bars were added to facilitate the deployment /retrieval of the robot, on the manhole, preventing the shell from colliding with the manhole walls (see Figure 4.13).

Figure 4.13 - Protective aluminium bars

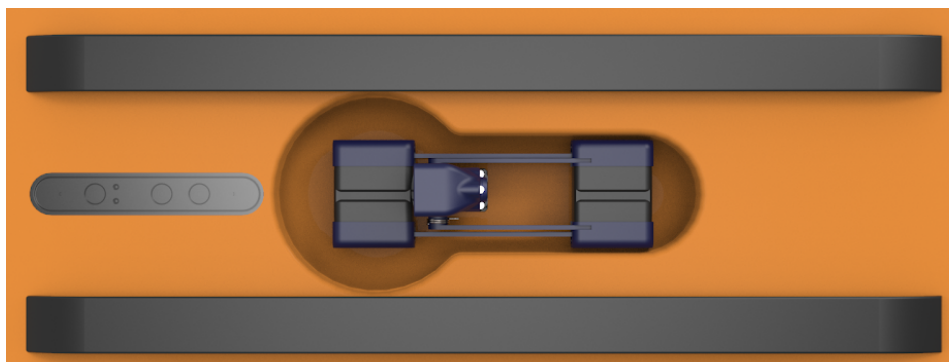
Also on top, a hole containing the robotic inspection arm camera will prevent the arm and camera from being damaged while the robot passes through the manhole. The motors and motor sensors are now inside a protective and waterproof shell (see Figure 4.14).

Figure 4.14 - Robotic arm camera container

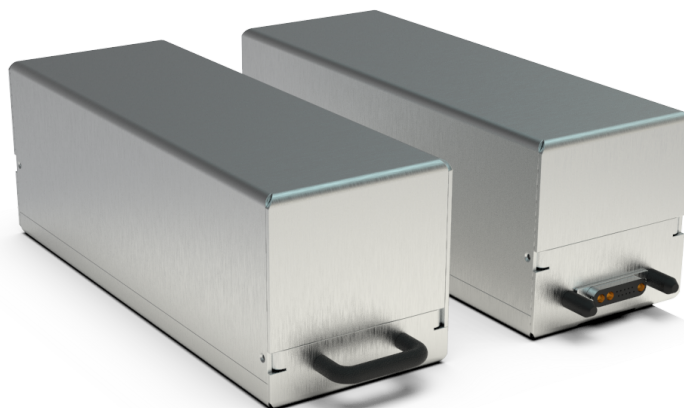
Each set of 2 batteries will be isolated and installed in a drawer as shown in Figure 4.15.

Figure 4.15 - SIAR battery sets

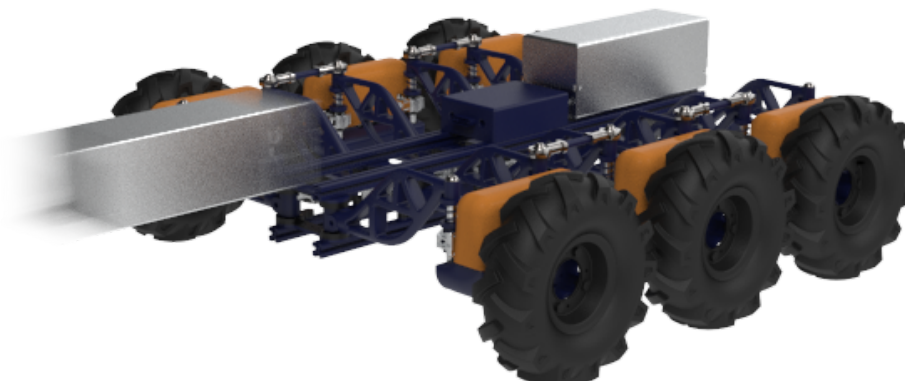
The drawer with the batteries will enter the robot in a sliding motion and perform a isolated contact with interior electronics (Figure 4.16). This way the battery changing time will be dramatically reduced.

Figure 4.16 - Battery drawer

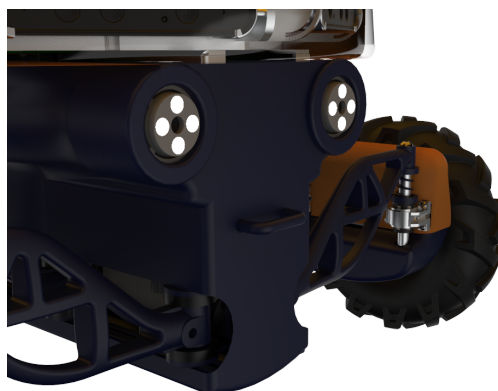
The motors power connectors and sensors will enter the main isolated body using IP67 power and signal connectors. The illumination will also be installed on the robots body, inside an IP66 enclosure as shown in Figure 4.17).

Figure 4.17 - Environment robot illumination

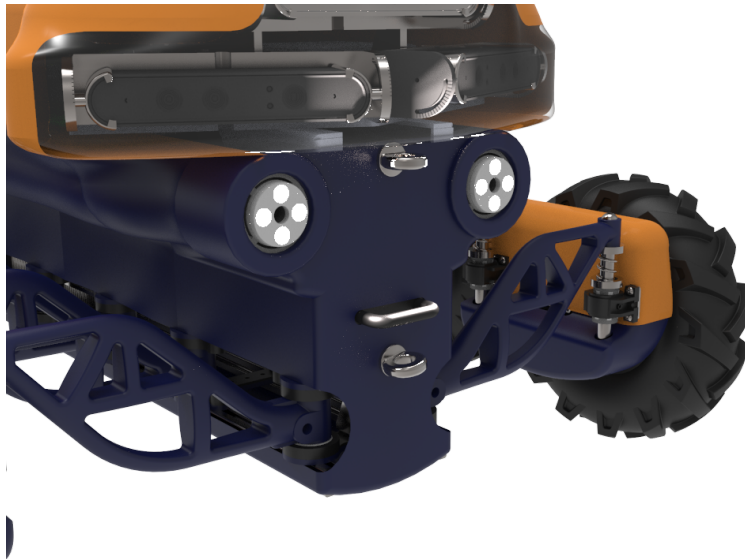
To ease the downing and lifting of the system, two eye bolts were fixed to the robot structure, as shown in Figure 4.18.

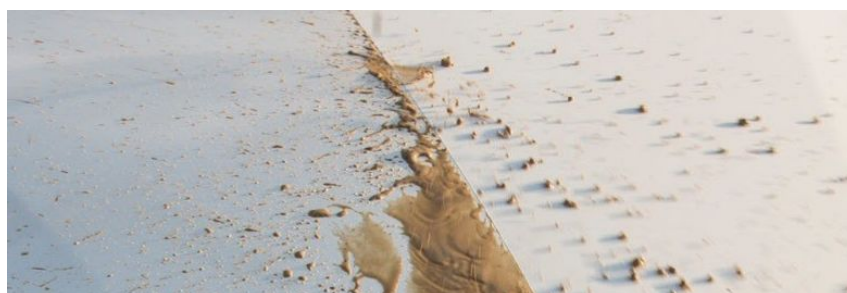
The camera windows will be coated with a hydrophobic spray that will maintain the windows clean from dirt. This hydrophobic layer will repel any dirty water that may fall over the camera windows. Figure 4.19 shows a surface where such layer was applied on the right side.

Figure 4.19 - Hydrophobic surface (right side) with mud

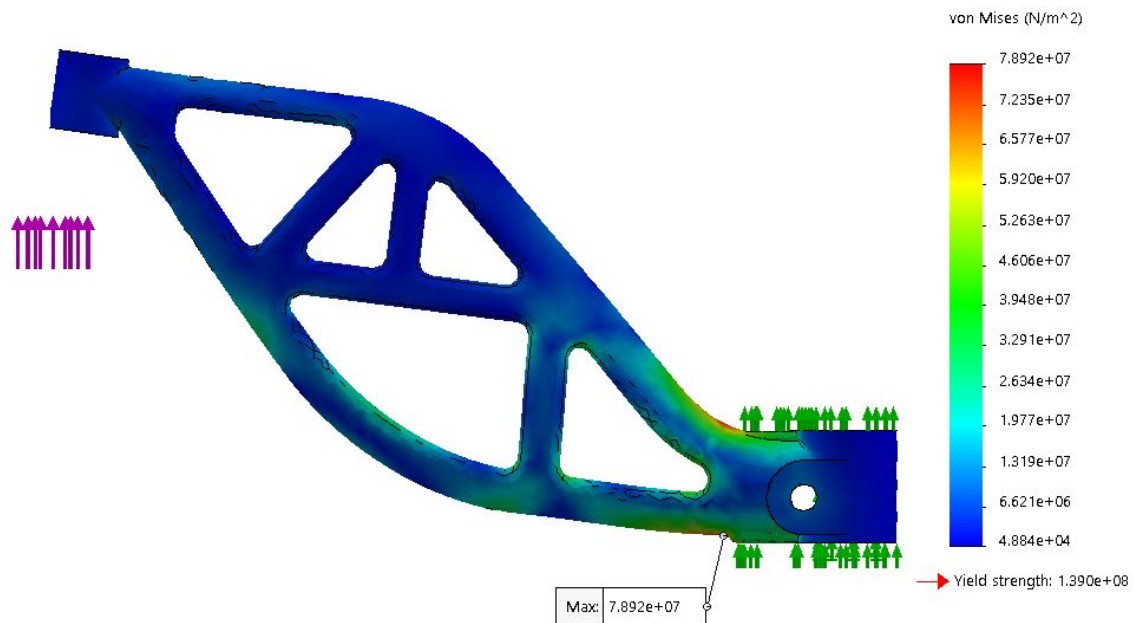
according to results. This was the case, for example, of the new suspension arms, designed in the high performance polymer ULTEM 1010. The arms were tested under the Von Mises yield criteria for a worst case loading scenario, with the results presented in figure 4.20.

Figure 4.20 - Worst loading scenario - full robot weight on one wheel (600N)

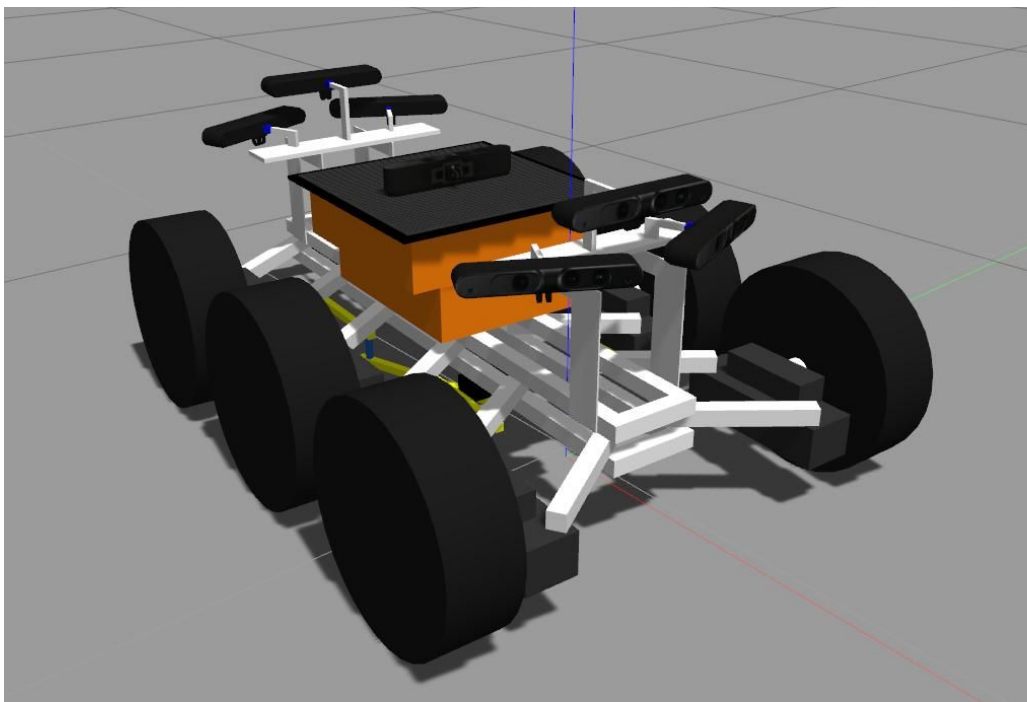
- Simulation of the 6 wheel configuration with spring damping system.
- Realistic dimensions, weights and dynamic parameters of the platform.
- Simulation of the width adaptation mechanism.
- Uses the same interfaces as the real platform.
- Realistic simulation of the RGB-D cameras.
- Scenarios obtained by employing the 3D reconstruction of the environment obtained as described in D28.6, Section 6.2.2.

Figure 5.1: Close view of the simulated robot

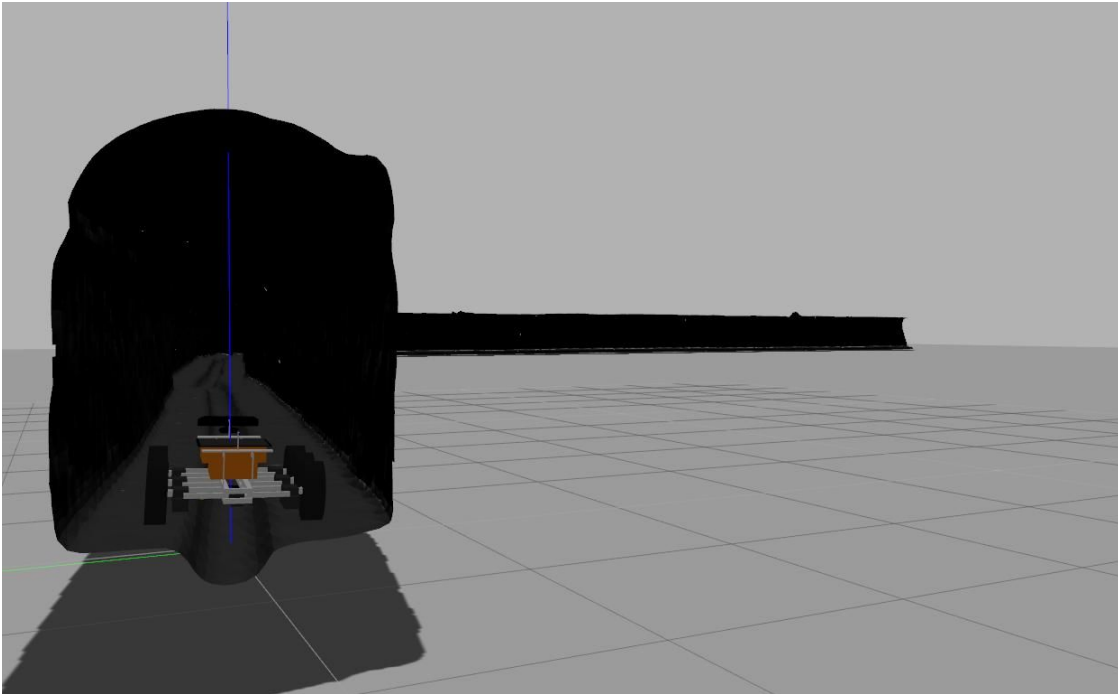
Figure 5.2. Robot navigating into a 3D reconstruction of the real sewers.

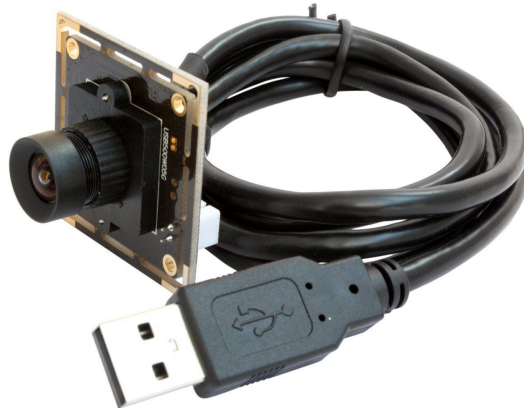
A new inspection camera will be installed in the robot arm located on the top (see Figure 5.3). This small camera allows recording at full HD with a very small footprint. The camera also delivers compressed images at 30Hz, allowing direct forwarding to the operator control station with minimal computation impact to the robot.

Figure 5.3: New camera that will be installed in the arm on top the robot.

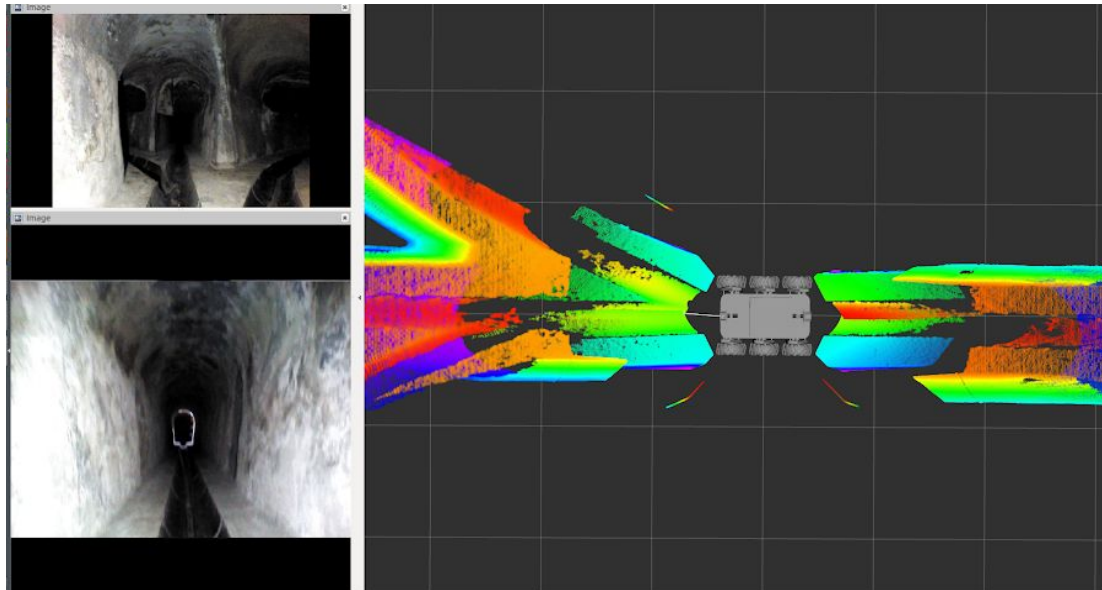
generator fuses the information of all the cameras in the aforementioned map. Figure 5.4 shows the point clouds acquired in the surroundings of the platform at one time. Please note that the point cloud almost completely surrounds the vehicle while the small gap between the robot and the closes part of the clouds is below 20 cm. Figure 5.5 illustrates one of these traversability maps that are used to generate trajectories. Again, the maps provide information in very close areas.

Figure 5.4: (up left) Image from the front camera. (down left) Image from the rear camera (right) Combined point cloud of the six navigation cameras.

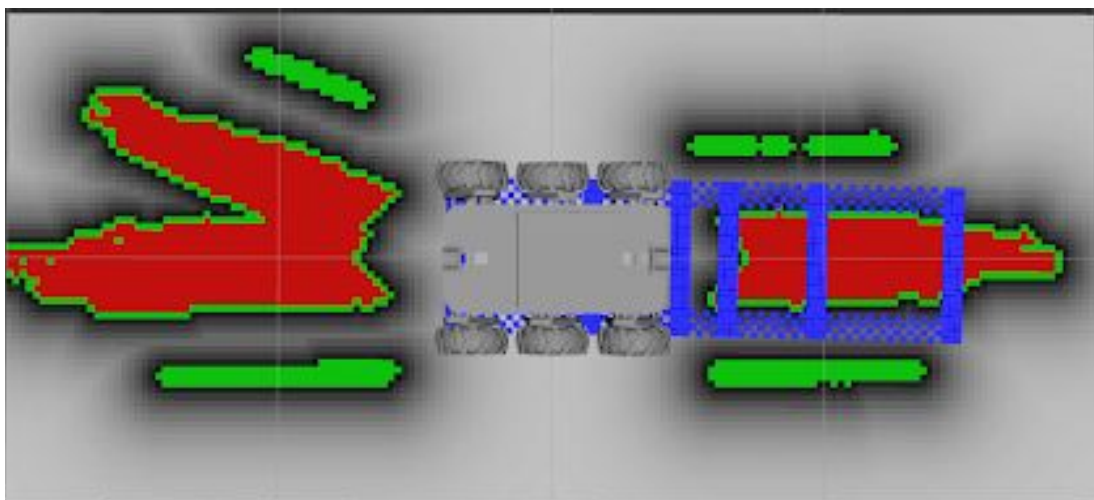
Figure 5.5: Traversability map associated to Figure 5.5. The red areas indicate negative obstacle, the green ones positive obstacles, light gray areas mean no obstacle. The footprint of the generated trajectory is marked in blue.

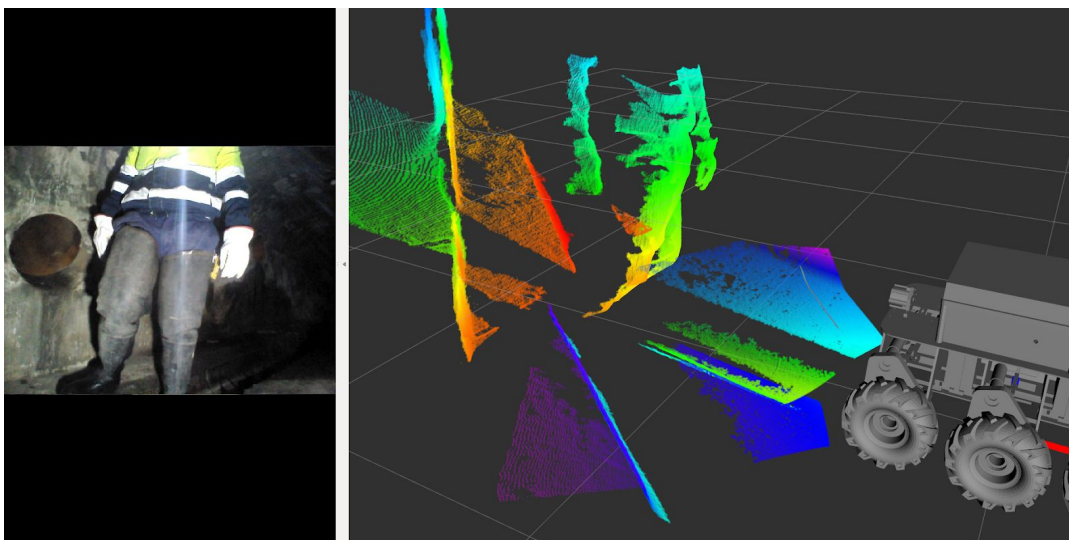
We are nevertheless taking some actions. In semi-autonomous mode, the robot will automatically stop if there are obstacles nearby, including persons. The enhancement of the estimation of obstacles surrounding the robot, as described above, will improve thus the safety of persons around.

Figure 5.6: Detail of depth information gathered in the presence of one operator. The operator can be detected from more than one meter. If the robot is moving in the direction of the operator, it will automatically stop (semi-autonomous mode).

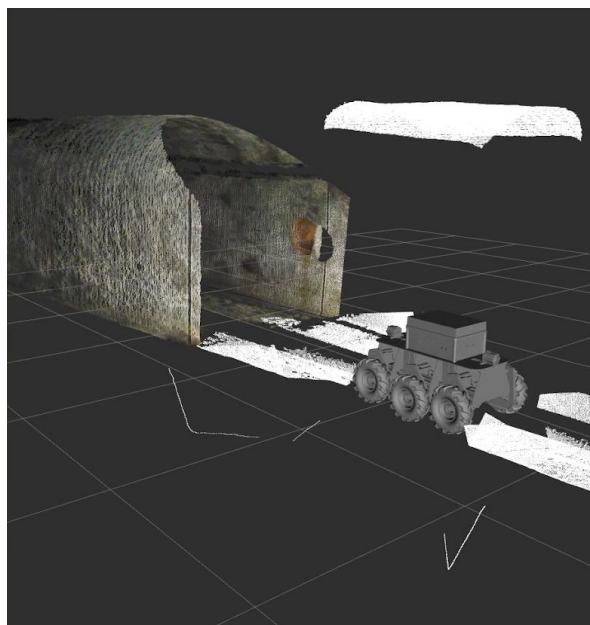
As commented, the system is able to provide 3D reconstructions. Using the 3D data it is possible to make measurements on dimensions and distances, but during the demo we did not have any specific tool for that. We are working on tools for measuring distances in the Control Station. It is tricky to adequately do so using a 2D representation, and we will include references, as the own model of the robot and grids (see Fig. 7.3), to help in the process of measurement.

Figure 7.3: The 3D information provided by the robot can be used by the operator to perform distance measurements. The robot model and grids (in the view each square represents 1 square meters) will help in the process.
