Final prototype and validation for sewer inspection procedure

ARSI Deliverable D26.14

PDTI Urban Robotics - Sewer Inspection

December 20, 2018

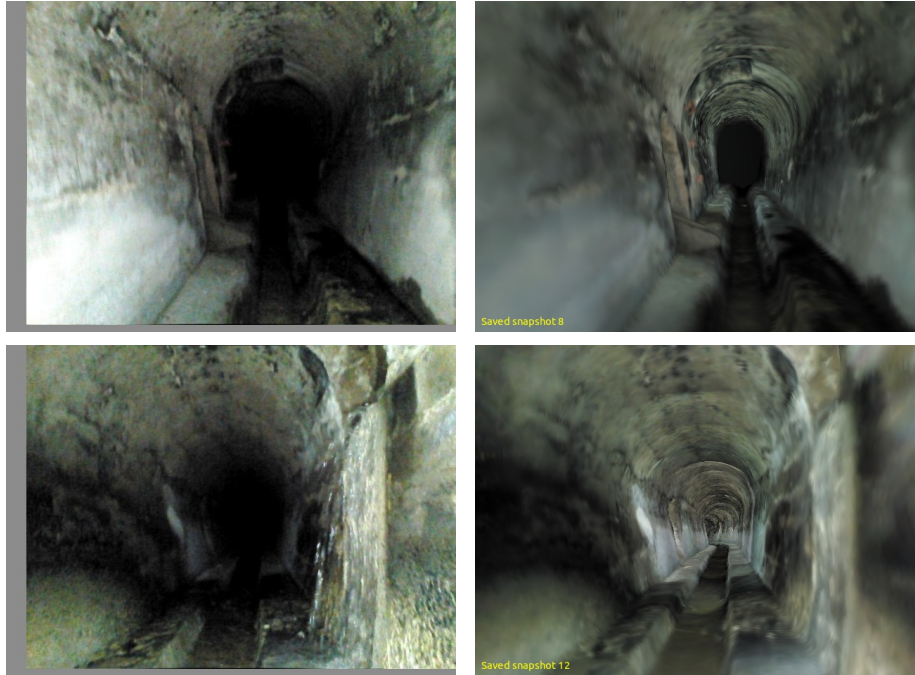
Figure 12: Comparison between images captured by the MAV (left) and the obtained reconstruction of the sewer model (right).

Figure 12 finally compares the obtained reconstruction of a sewer with the captured images by the MAV. One can observe how the models obtained with the new reconstruction and texturing approach almost matches the quality of the image, leaving aside changes on the lighting which are corrected during the texturing stage.

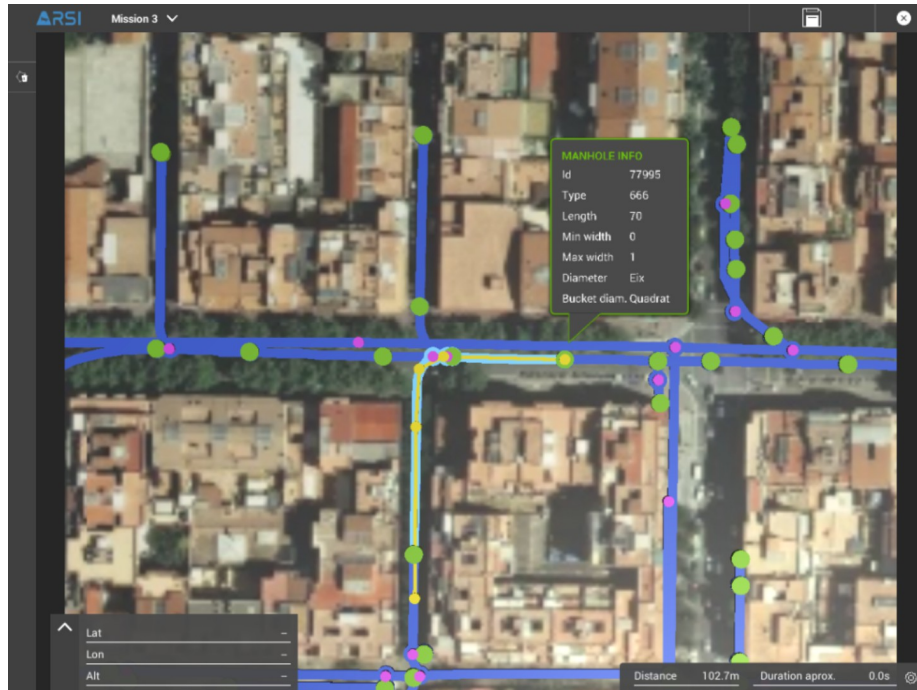
Figure 15: ARSI Mission Planner interface

A Mission Planner interface (see figure 15) was developed during phase III. It allows ARSI users to load GIS data and satellite imagery for the area selected by the client, and to plan a series of flights with the ARSI MAV in order to collect inspection data for the relevant sewer sections.

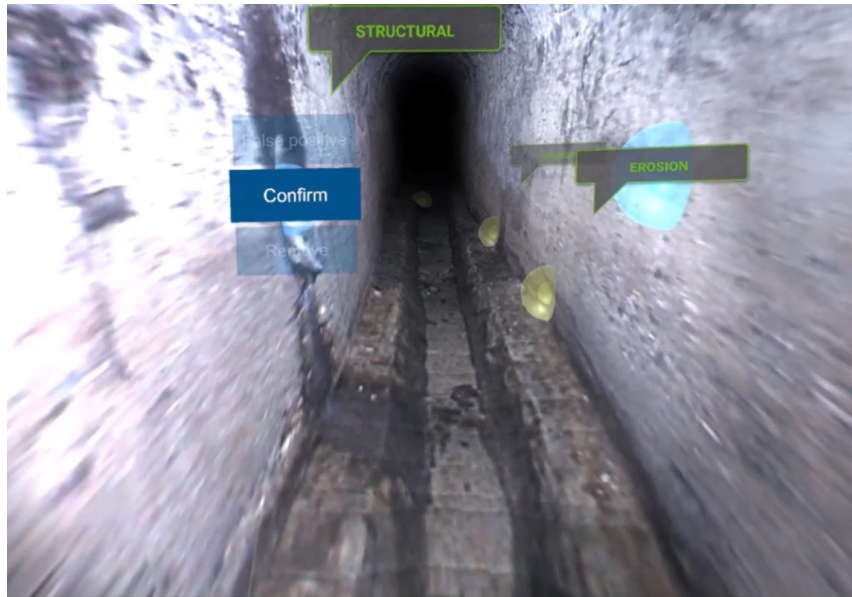
Figure 19: ARSI Data Analysis tool working in immersive mode.

- The drone navigation can be controlled by using the VR touch controller. The tool allow bidirectional navigation with adaptable speed. The operator can also travel to a specific place just pointing it with the VR controller in a similar way to the desktop version.

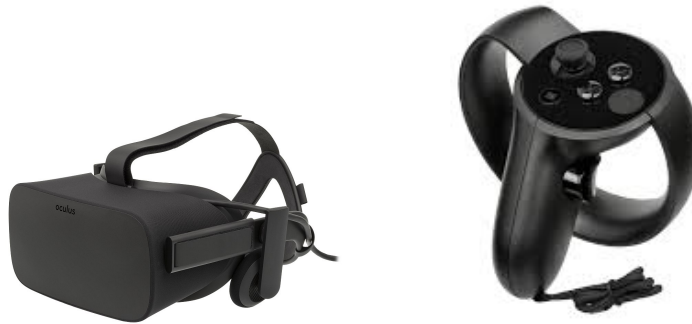
Figure 20: Integrated VR devices. Left, Oculus Rift headset, Right, Oculus Touch Controller.
