Sewer **i**nspection **a**utonomous **r**obot

D28.15 - Multimedia Report

SIAR Consortium

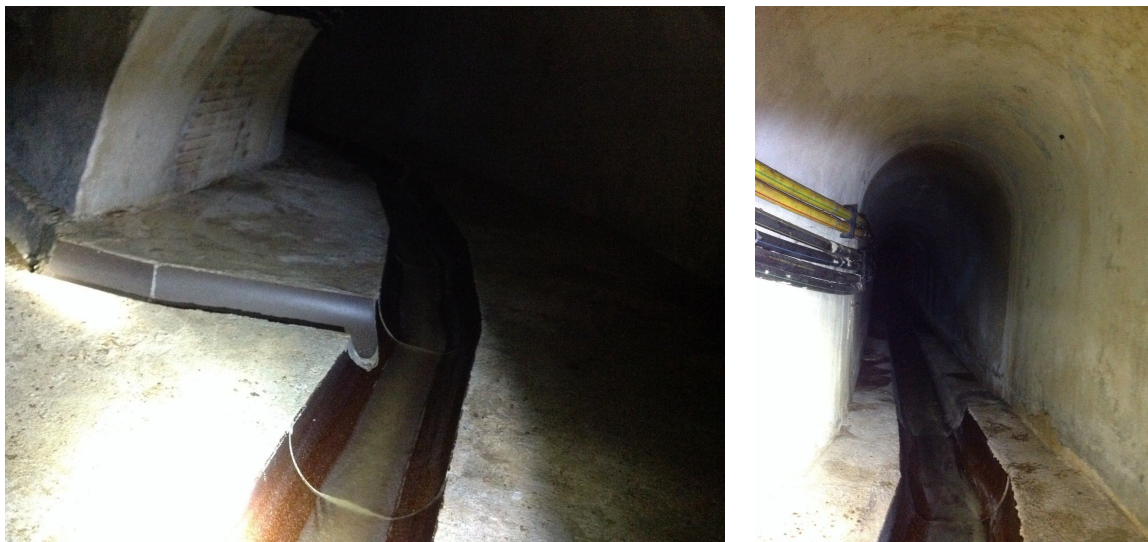
The T-shaped fork between segments 2 and 1 is represented in Figure 2.3 (left). It was easily handled by the robot.

Figure 2.3. (left) Fork between segments 1 and 2. (right) Start of the third segment.

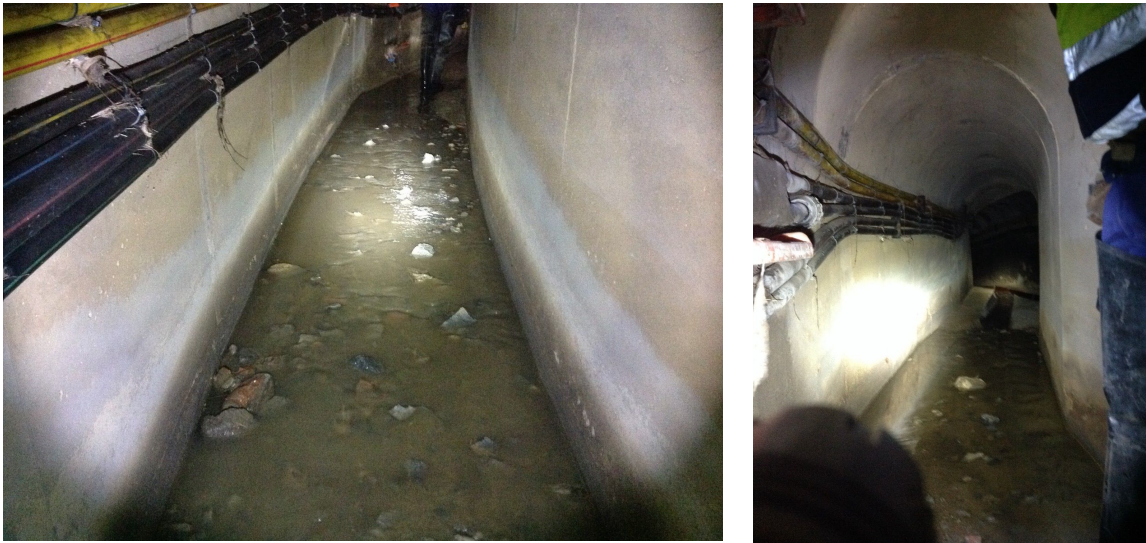
This section presents some accumulation of water in the middle with sediments as shown in Figure 2.4 (left). Just before the end of the segment, when it reaches segments 4 and 5 the sediments disappear as shown in Figure 2.4 (right). This figure was captured just below manhole 3. We measured the height of the sediments. They were 15 cm high approximately.

Figure 2.4: (Left) Sediments in the middle of segment 3. (Right) The sediments end just before reaching segments 4 and 5.

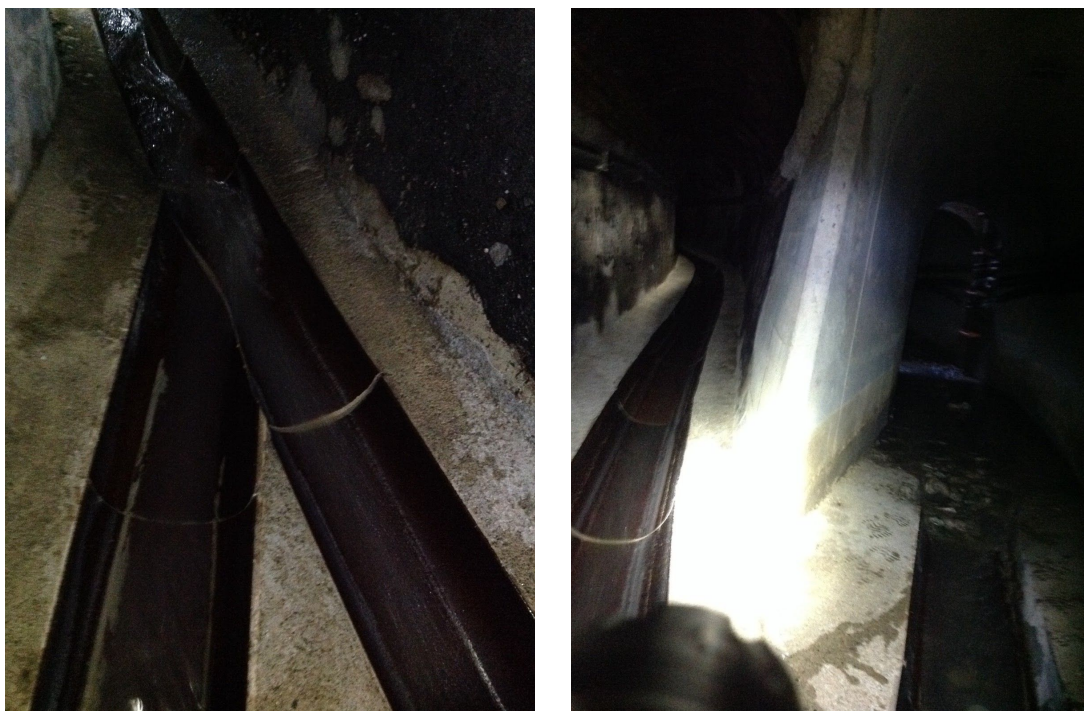
This segment meets with segment 4 with the opposite direction of the water flow (upwards) and segment 5 with the same direction of the water flow (downwards). Figure 2.5 (left) represents the fork while 2.5 (right) represents the place where segments 3 and 4 meet.

Figure 2.5: (Left) Fork between segments 3, 4 and 5. (Right) section where segments 3 and 4 meet.

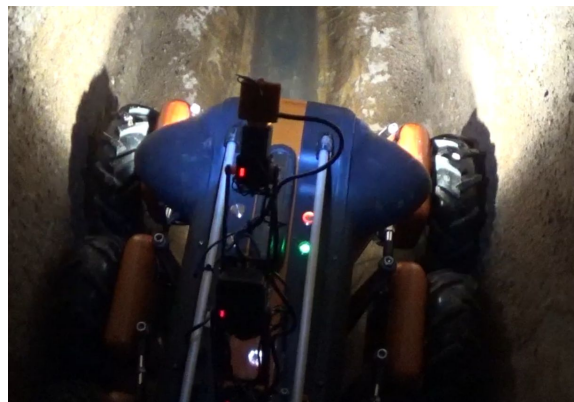
A short experiment was carried out to further test the new platform in the structural defect scenario. The test started at 13:14 (local time), and it was carried out successfully in less than one hour. The new SIAR 4.0 platform is represented in Figure 2.9 during the course of the preparation experiments.

Figure 2.9: New SIAR 4.0 during navigation in the Av. Pearson area.

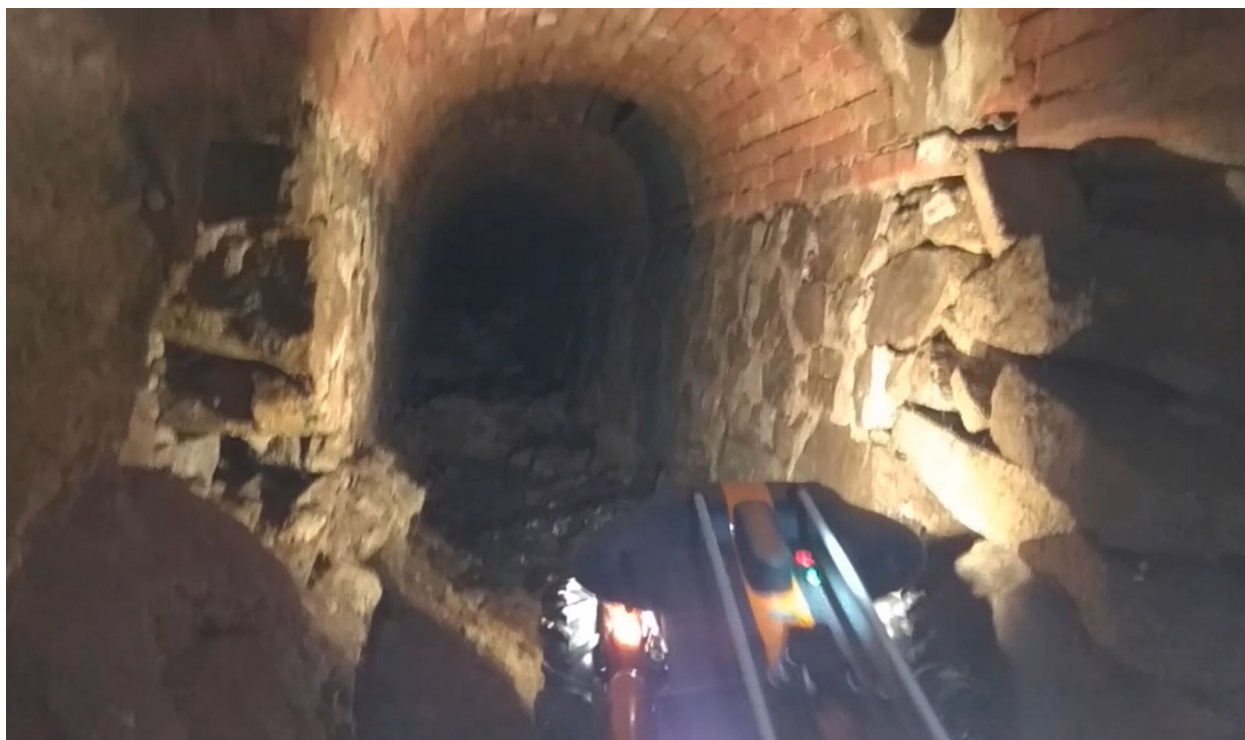
The new version of the SIAR platform was presented to different people of the organizing committee of the Challenge for Sewer inspection, including Lina Martinez (BCASA), Ana Puig Pey, Alberto Sanfeliu and Antoni Grau. The experiment was carried out twice to be able to present the results to all the evaluators. They were pleased with the new version of the platform and in particular they found very convenient the inclusion of a new arm with a camera on the end effector. This camera was used for navigation and inspection purposes during the demo. Figure 2.10 shows the platform while navigating in the area with structural defects.

Figure 2.10: New SIAR 4.0 during the Structural Defect Demo.

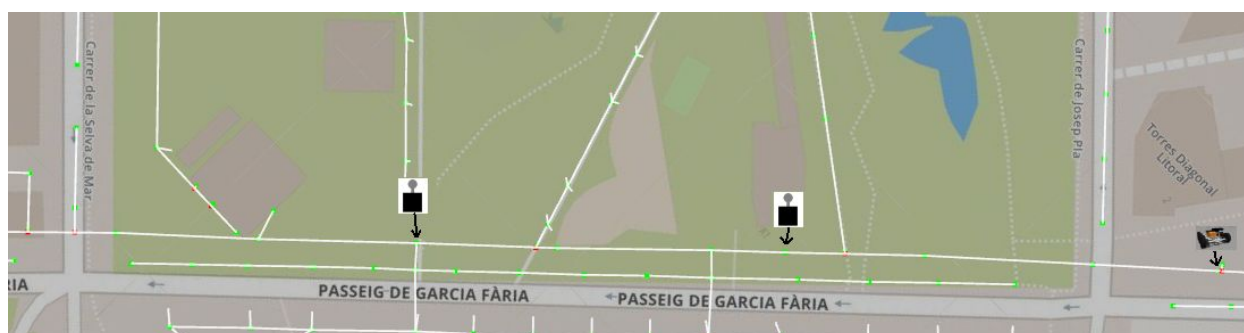
The location where the final demo was carried out was a linear gallery at the Passeig Garcia Faria, as seen in Figure 2.11. The navigation presented less difficulties in this location as the section was constant and no forks were present in the track. This allowed us to perform the complete inspection procedure in autonomous mode and to travel about an half kilometer in less than one hour.

Figure 2.11: Inspection plan for *Passeig de Garcia Fària* area. The black boxes indicate the position of the repeaters and the robot points to the deployment manhole.

In these experiments, we performed the complete deployment of the system including the addition of two repeaters as presented in Figure 2.11. In both days of the experiments, we managed to drive the SIAR platform along a 300 m long path without any issues in autonomous mode.

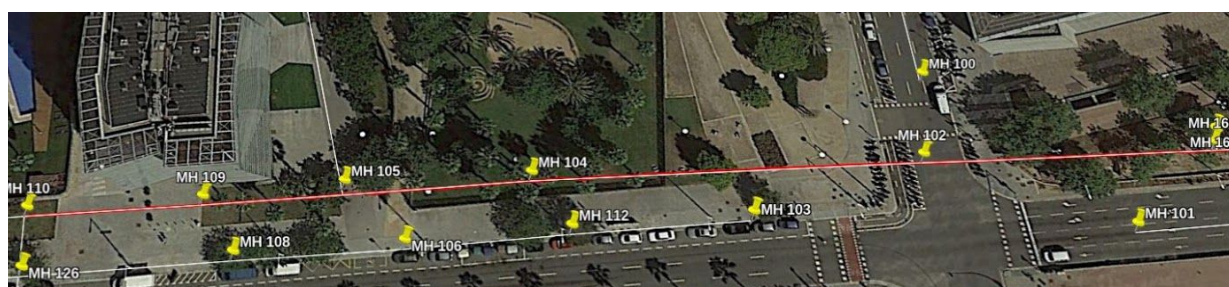
The complete inspection procedure was carried out in semi-autonomous mode with the exception of the need to deal with a big obstacle. The robot traveled a total of 400 m in less than 40 minutes, which gives an average inspection rate of 0.18 m/s. Figure 2.13 shows the track that was actually inspected during the final demo.

Figure 2.13. The inspected track on the Final Demo is shown in a red line.

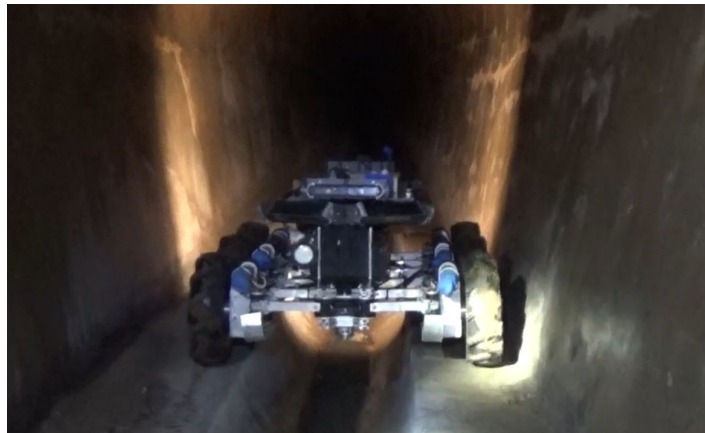
This video presents a portion of the SIAR V3.0 platform while navigating through the sewers in the Virrei Amat area.

Figure 3.1: The SIAR V3.0 platform navigating in the Virrei Amat area.

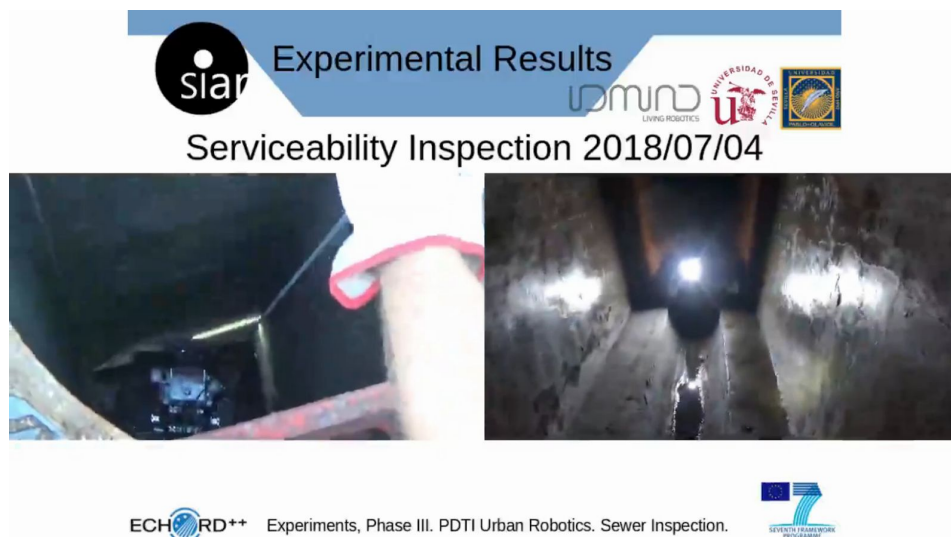
A summary of the report obtained in the serviceability demo and the technologies used inside.

Figure 3.2. Video of the serviceability report.

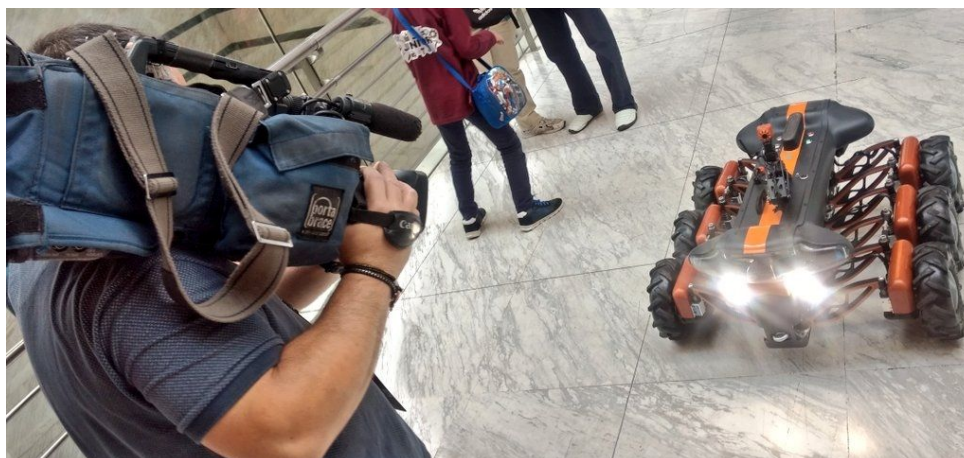
On September 17th, the new version of the SIAR platform was ready to go to the sewers. The principal novelties were the new width adjustment mechanism, that allowed the SIAR to have a width ranging from 52 cm to 84 cm. Also, a new operator awareness camera was installed and mounted on a robotic arm, that allows the operator to gather more information of the possible defects found during an inspection and to have more information for guiding the platform in complex areas. The video also presents some excerpts of field experiments in Av. Pearson area.

Figure 3.3. Presentation of the V4.0 SIAR platform at IROS 2018

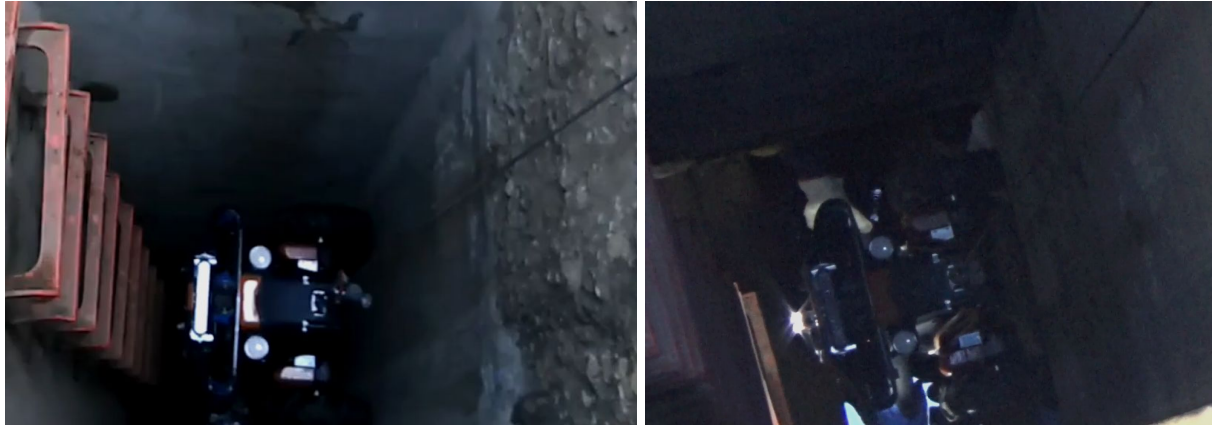
These videos show the new configuration found to easily deploy the robot in the Av. Pearson area. In particular, we found that the safest procedure was to push the wheels against the wall while deploying or retrieving the platform.

Figure 3.4. Deployment of the V4.0 SIAR platform. Left: Video 1. Right: Video 2.

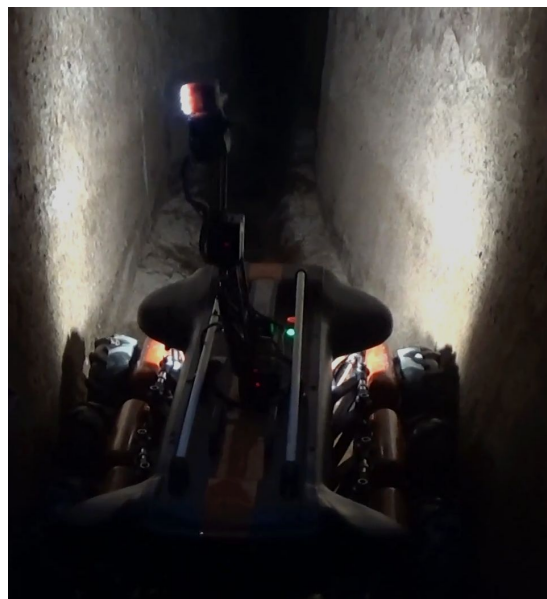
Small video that shows the transition between the arm in rest position to a navigation configuration.

Figure 3.5. Detail of the inspection camera installed in the arm end.

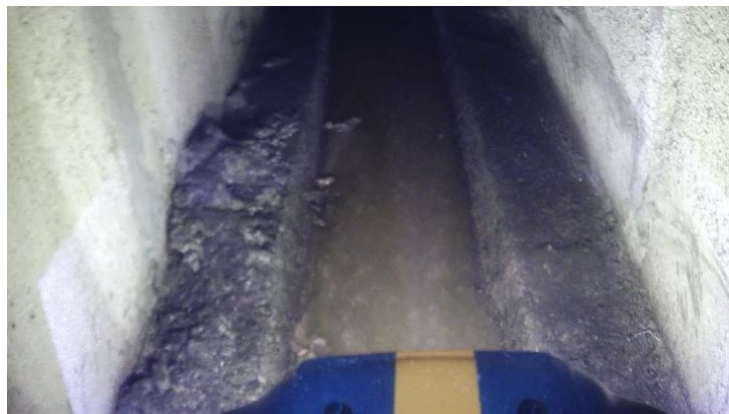
This video is a compilation of images obtained from the robotic arm in the Passeig Garcia-Faria location.

Figure 3.6. Image obtained by the inspection camera installed in the arm end.

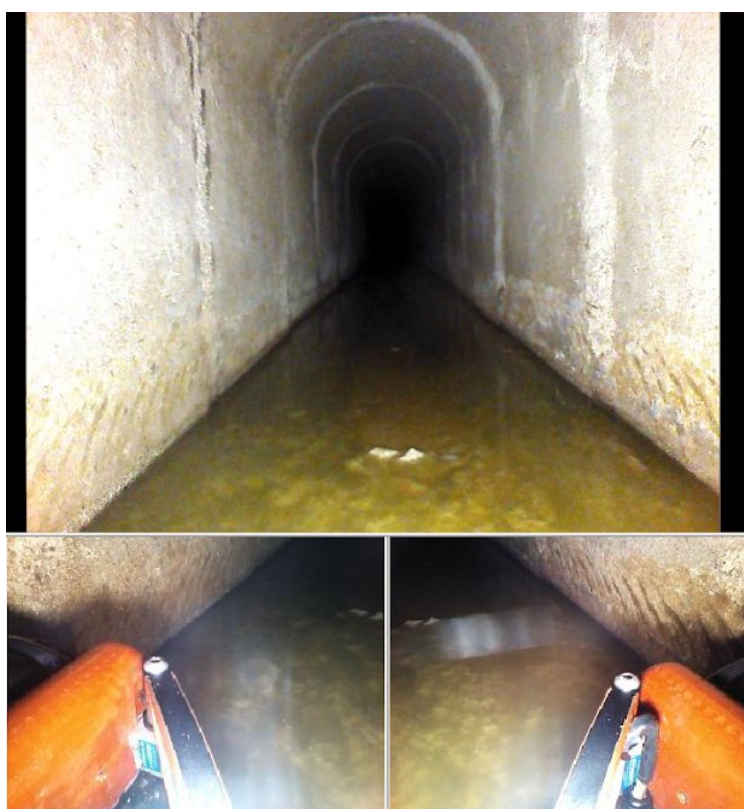
At the beginning of the inspection, our serviceability analysis module detected a serviceability defect which is depicted in Figure 3.9.

Figure 3.9: Composed snapshot of three frontal cameras in the Serviceability Defect in the Passeig Garcia-Faria area.

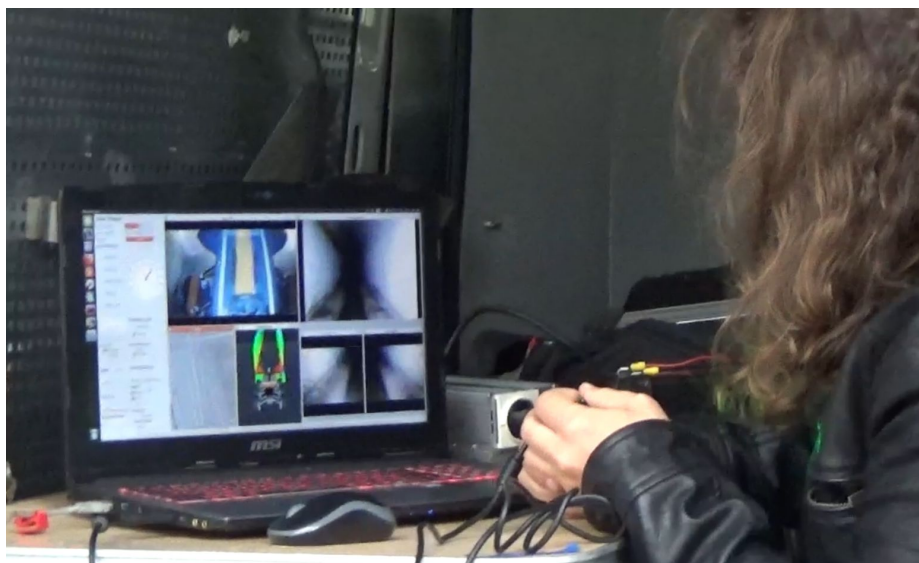
This video shows how the operator is able to guide the SIAR platform without any efforts and the real-time information offered to him.

Figure 3.11: An operator guides the platform from the surface.
