Sewer **i**nspection **a**utonomous **r**obot

D28.10 - Serviceability Inspection

SIAR Consortium

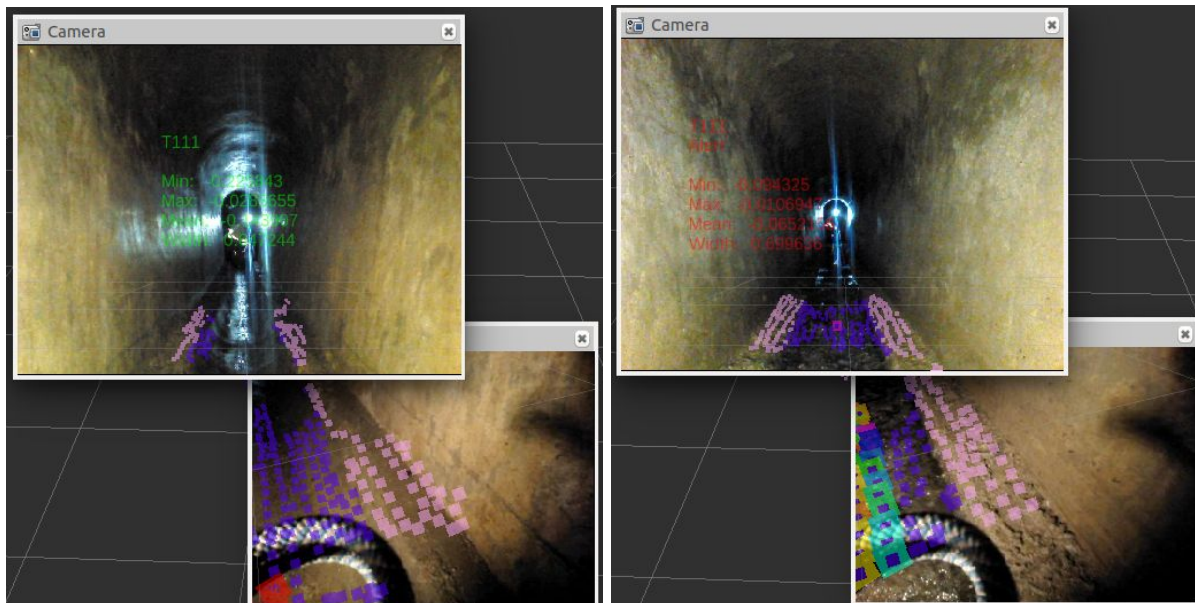
Figure 2.5: Left: the serviceability of the gallery is correct. The frontal and down right cameras are shown (there is a down left camera that is not shown for clarity). In green, the absolute values for the height of the gutter are displayed in the frontal image for the operator. In purple and pink, the 3D points corresponding to the gutter and curb respectively. Right: serviceability alarm. The values are displayed in red. Many of the 3D points in the down-right camera (marked as colored points) are detected as departing from the ideal section (the gutter is blocked by debris).
